INUNDATION MANAGEMENT ON SAIBAI, BOIGU AND IAMA ISLANDS

Drainage and Seawalls

September 2012

Prepared for the Torres Strait Regional Authority by AECOM

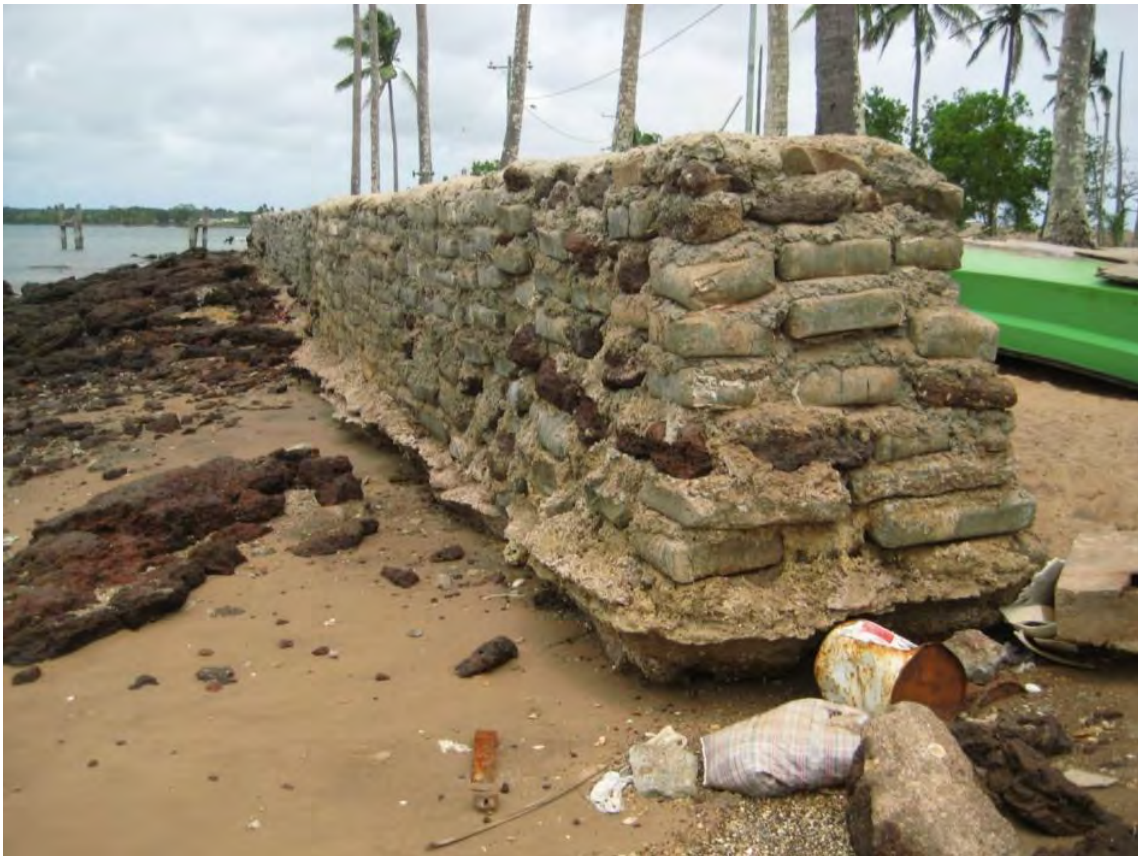
Along large lengths of the structures there is clear evidence of the toe of the existing seawalls being undermined by erosion of the foreshore (refer Figure 3). Any replacement structures will need to have toes properly designed to account for the coastal erosion. Any seawall with a brittle design that is vulnerable to rapid failure (e.g. Seabee or masonry structures) needs to be founded well below likely scour limits and preferably on the underlying coral platform.

Figure 3 Example of toe undermining

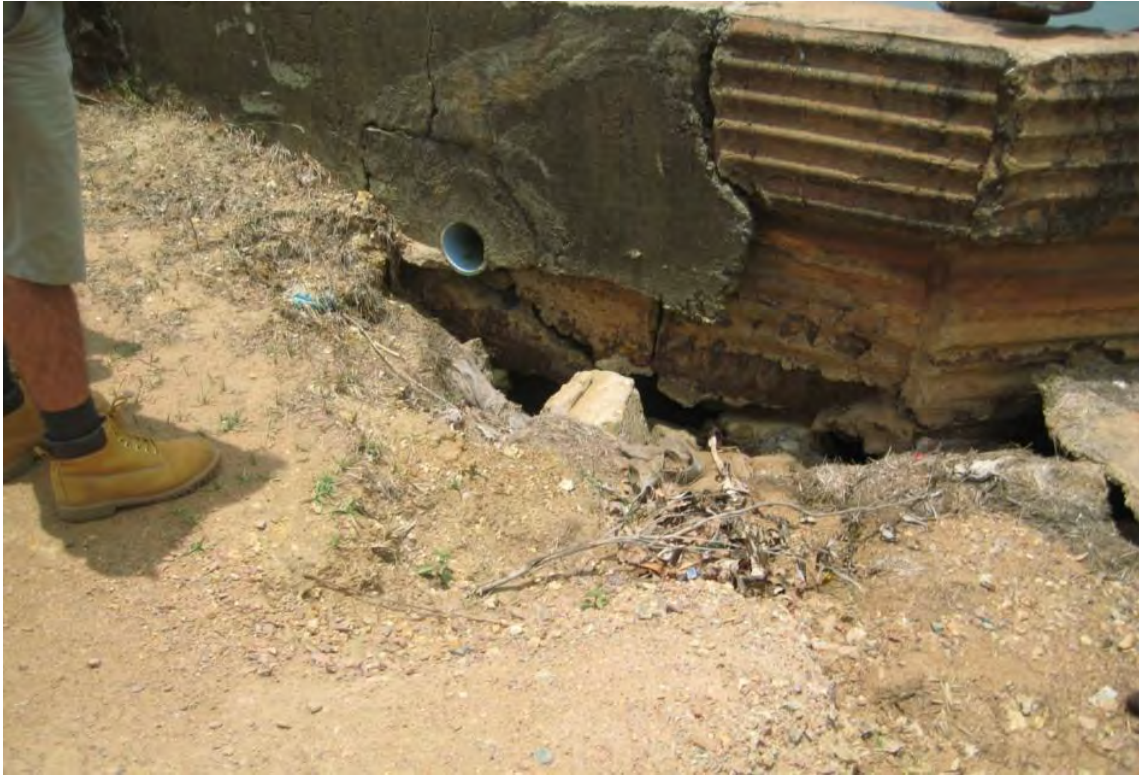
Piping failure is caused by water finding a flow path through the fill behind the wall and in the process washing the fill out, creating a “pipe” for the water to use. Piping failure results from lack of filter materials behind the wall, poor drainage (no alternate flow path) and undermining of the seawall toe.

Piping failure was wide spread along the wall and is contributing to wall failures and seawater intrusion issues (refer Figure 4). There have been many ad-hoc attempts to repair piping issues by placing fill, rubbish, and bags of cement into the holes (refer Figure 5 and Figure 6).

Figure 4 Example piping failure

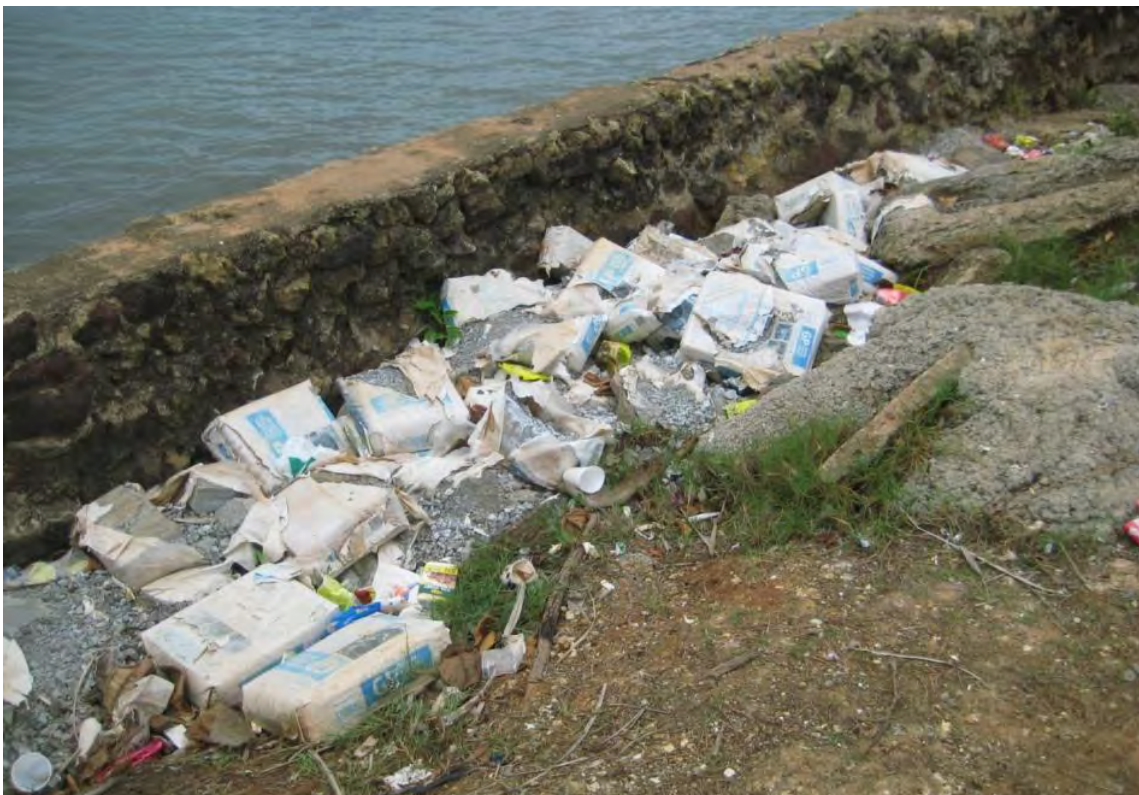
Figure 5 Bags of cement used to repair piping issues.

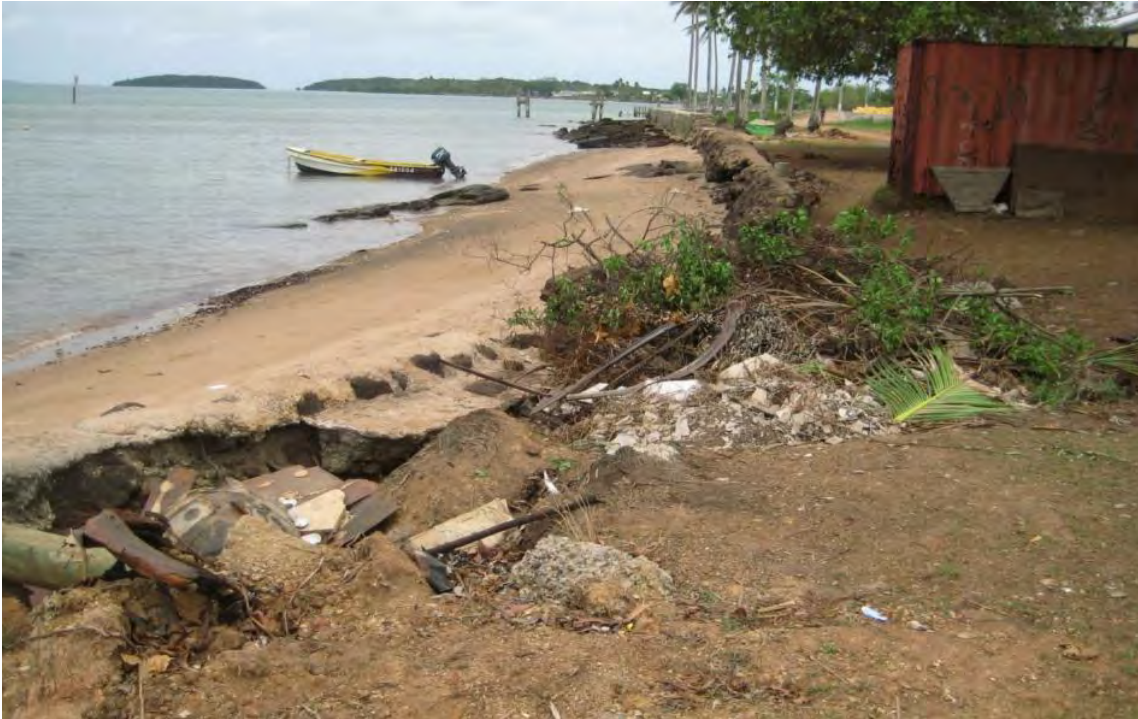
Figure 6 Rubbish used to fill piping failure holes.

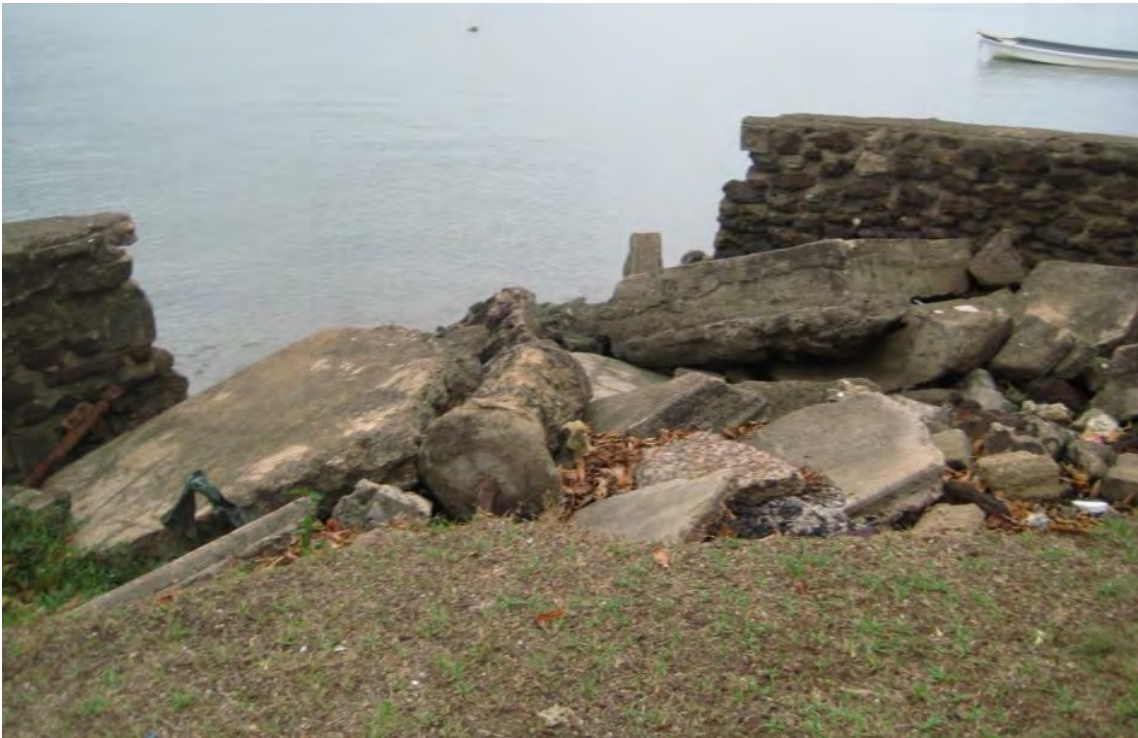
Figure 7 Failure (collapsed landward) due to piping and toe undermining

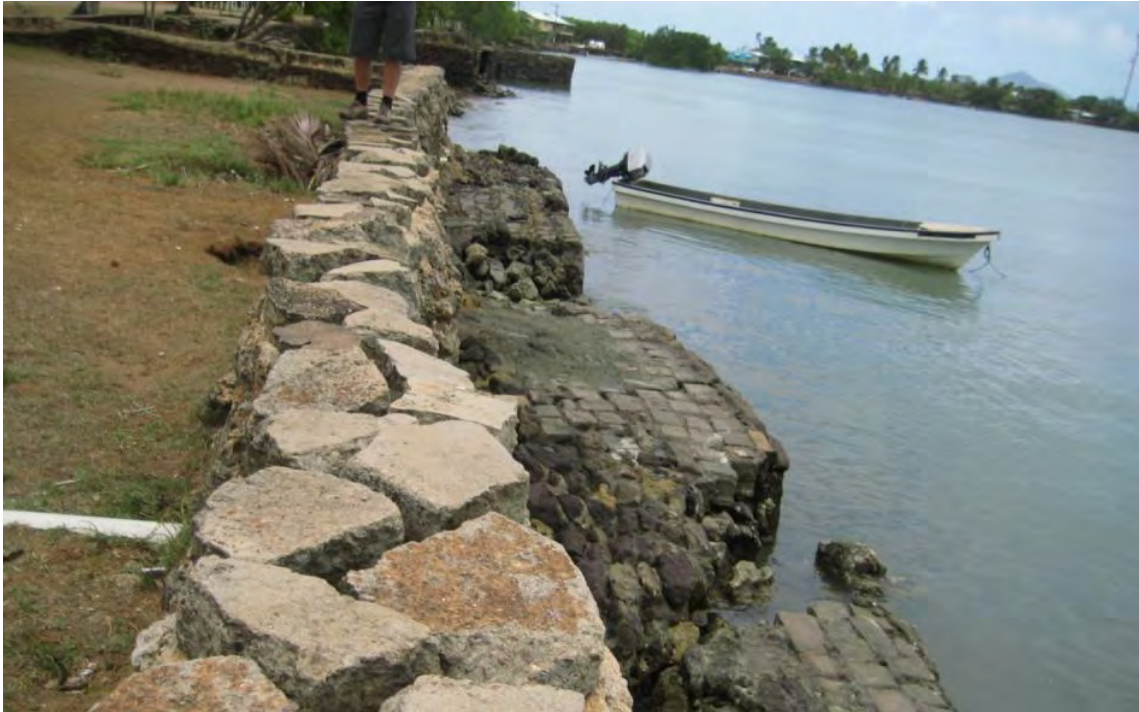
Figure 8 Failure (old wall collapsed seaward) due to toe undermining

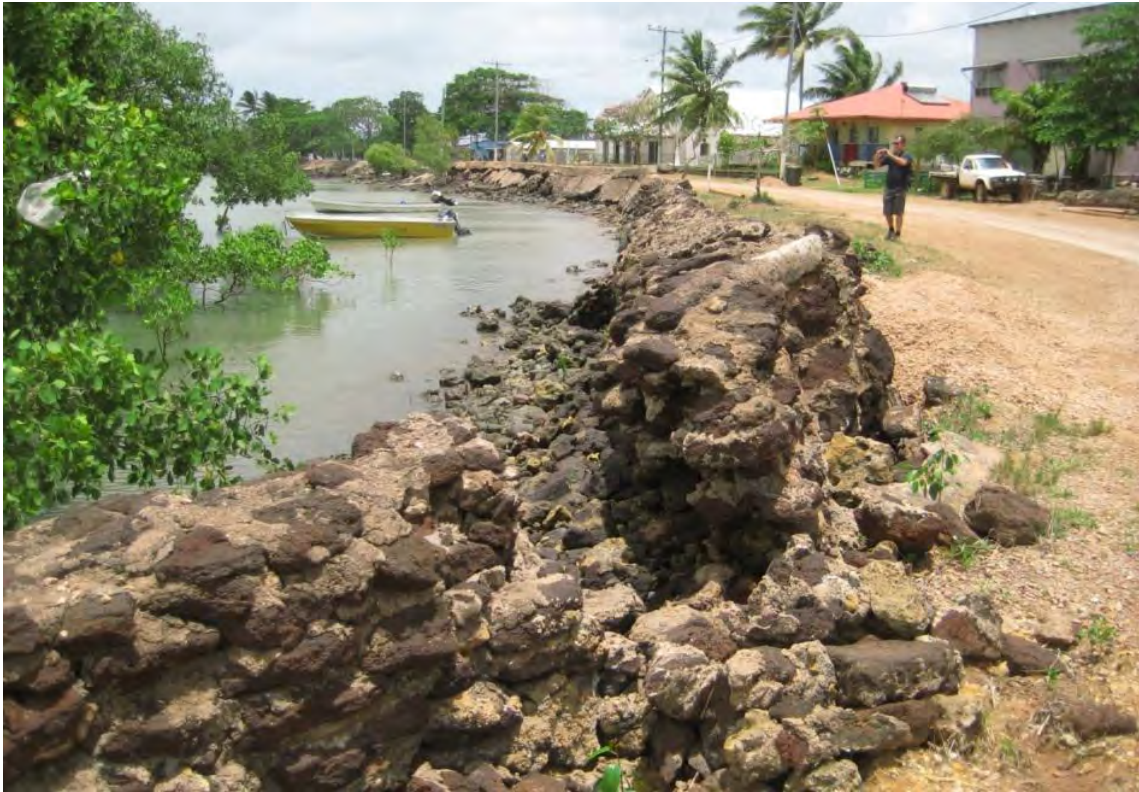
Figure 9 Localised failure (foreground) probably due to overtopping and piping more distant front face failure due to undermining of toe

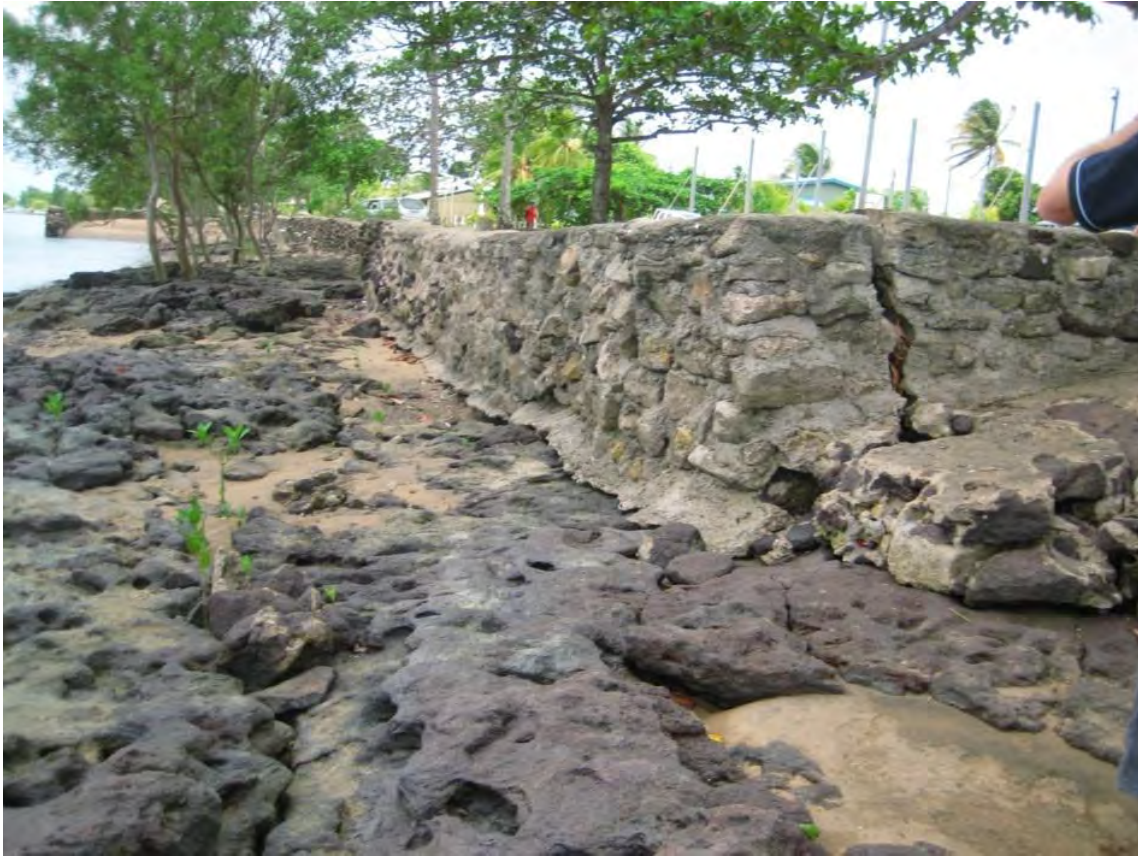
Figure 10 Section of wall with large cracks, ready to collapse seaward during high wave/water level event.

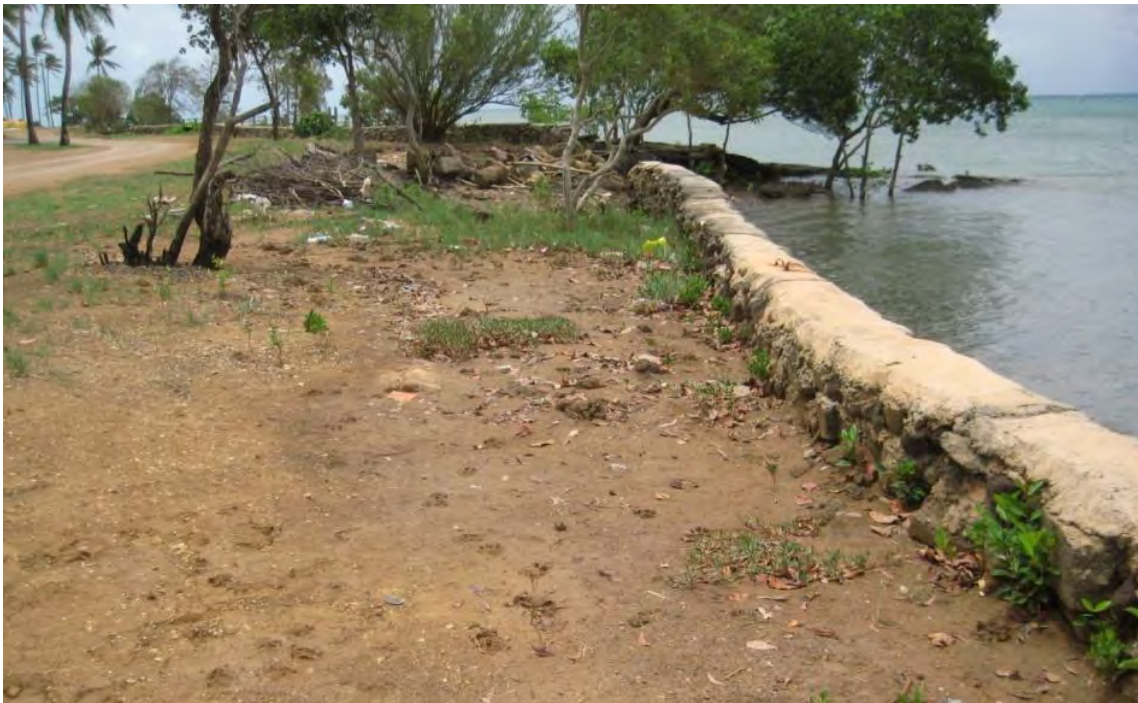
Some of the land behind the seawall is inundated so frequently that mangroves can grow on the landward side of the seawall in a number of locations (refer Figure 11). These areas will be inundated during normal tidal movements.

Figure 11 Mangroves growing on landward side of seawall.

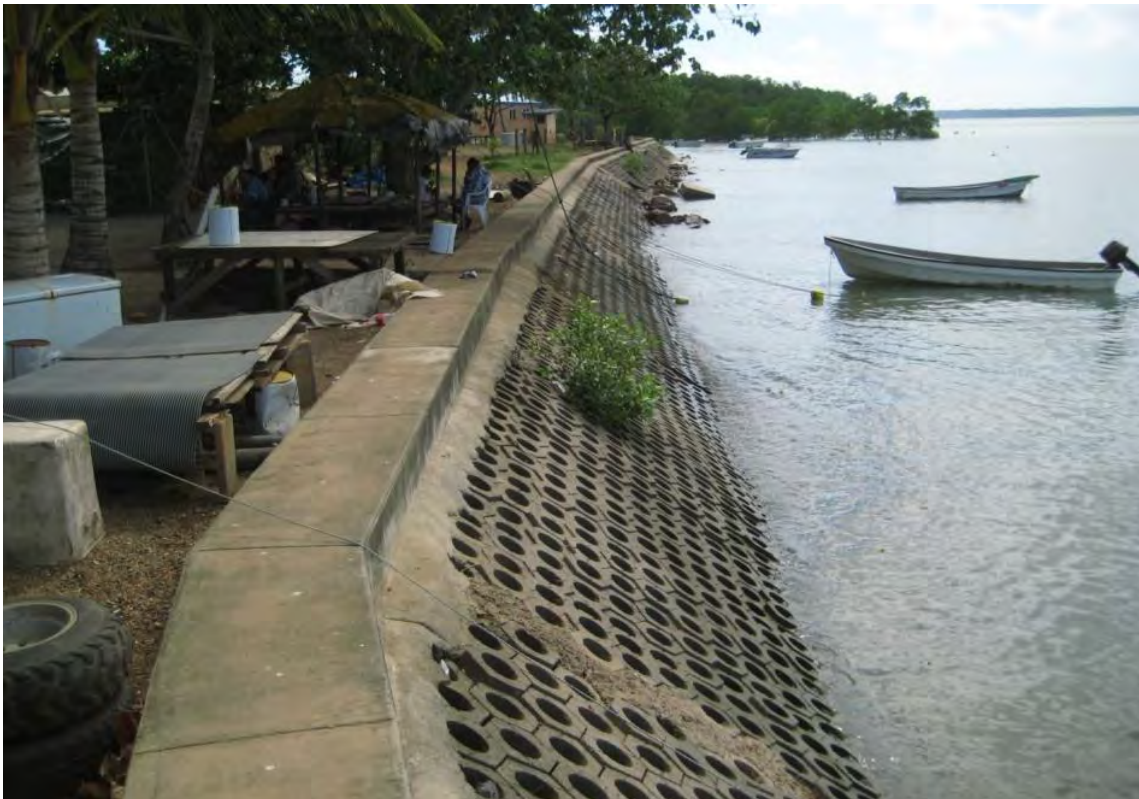
Figure 21 Seabee seawall in good order (note mangrove growing out of wall)

There are a number of mangroves growing through the Seabee seawalls (refer Figure 21). This vegetation needs to be removed to prevent the trees becoming large and the root system compromising the wall integrity. Poisoning or savage cut back is preferred to pulling the plants out as this may cause damage. The problem also exists in the rock seawalls but here the risks of damage are less significant.

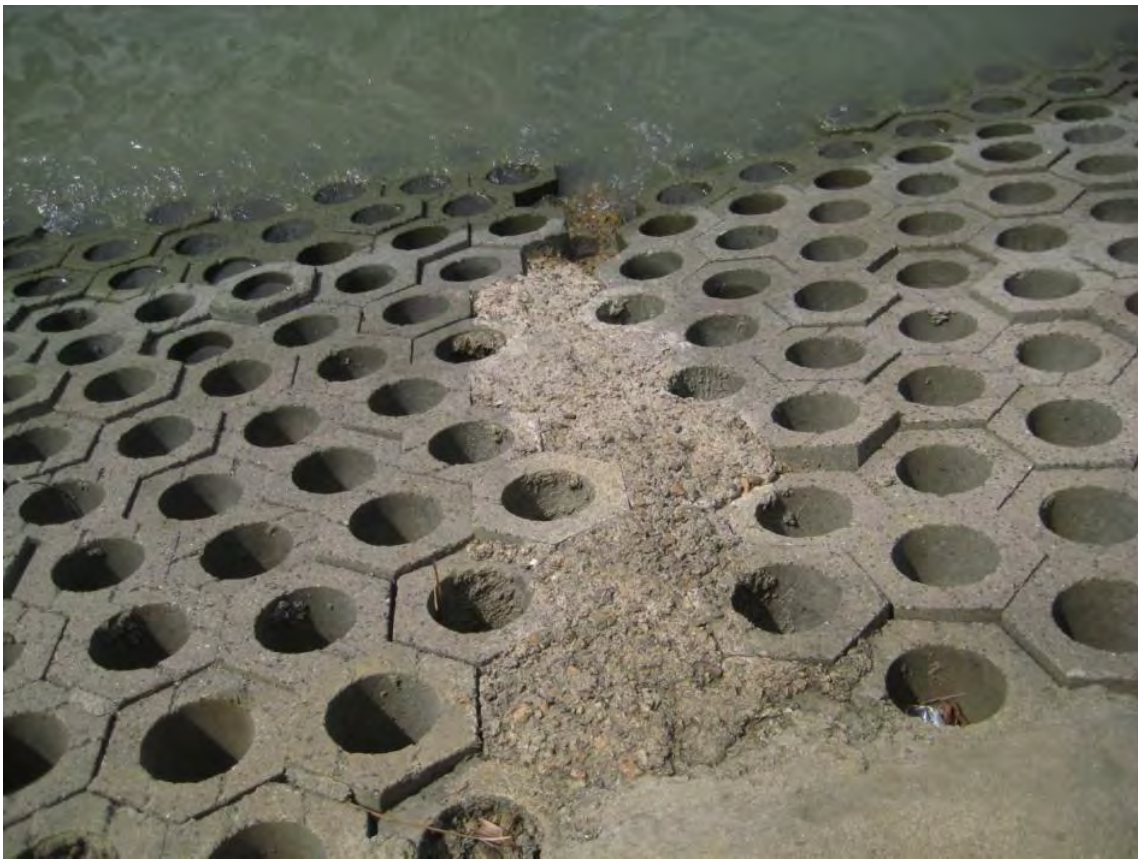
A number of junctions in the wall are in poor repair (refer Figure 22) and should be replaced/repared as needed. It may be prudent to replace some junctions with a set of concrete stairs to allow easy access down the face.

Figure 22 Junction in Seabee seawall

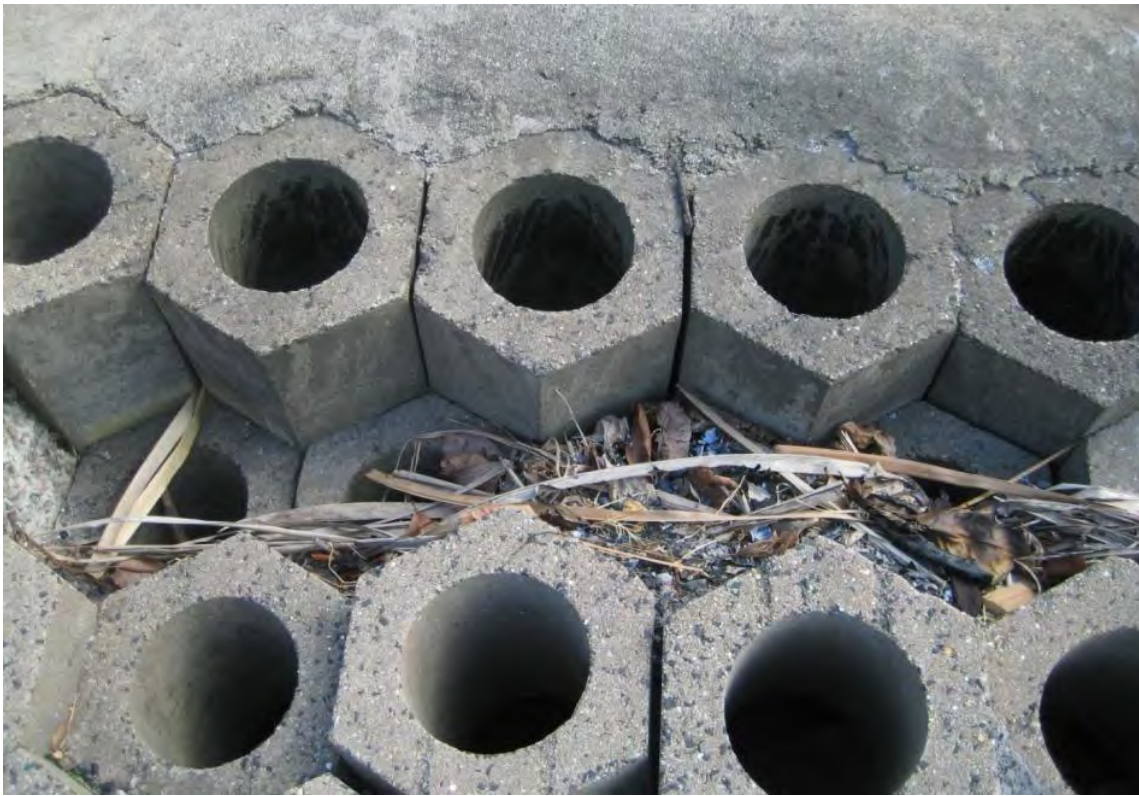
A section of the Seabee seawall has experienced excessive settlement (refer Figure 23) and the fill behind the capping beam has been washed through the armour below (refer Figure 24). On closer inspection it was apparent that bedding layers have been undersized and washed away and that a geotextile filter was absent (refer Figure 25 and Figure 26). Areas with excessive differential settlement (>100mm between armour units) require partial dismantlement and replacement from the top down, including:

Figure 23 Seabee settlement

- Installation of geotextile filter layer achieving at least 0.5m overlap with surrounding material
- Reinstall 0.3m thick bedding layer using rock in the range 65 to 165mm
- Reinstall the Seabee face
- Reinstall capping and end beams

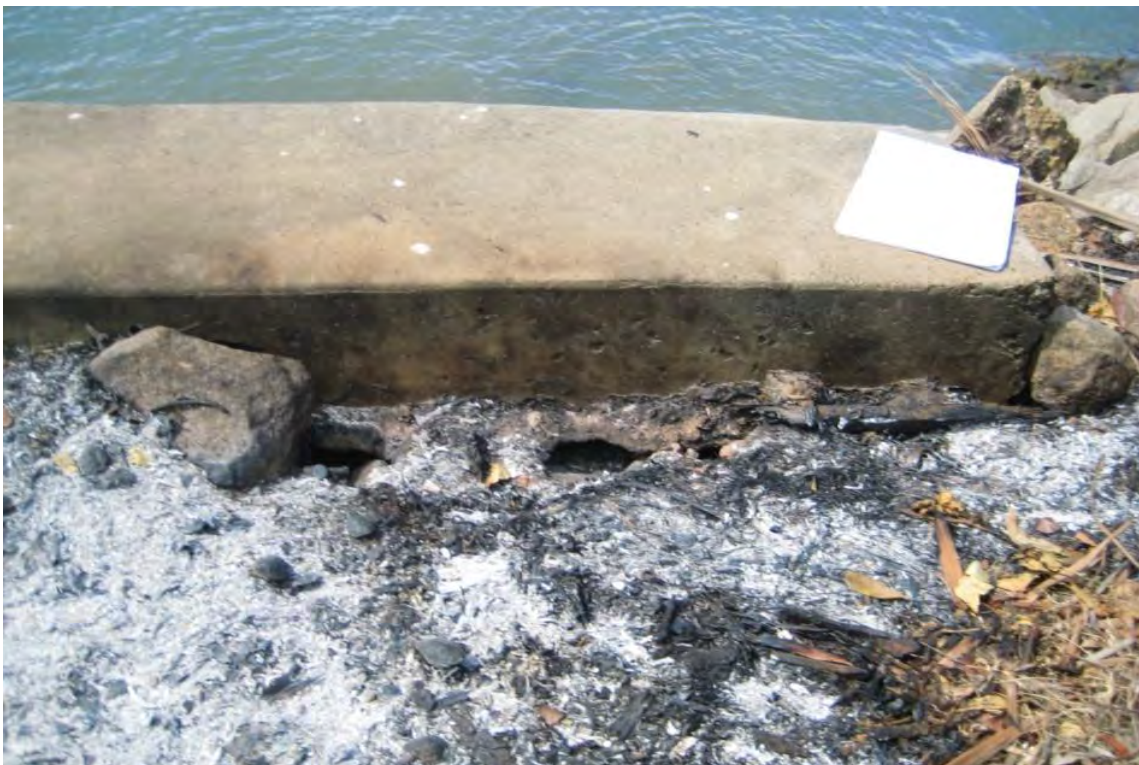
Figure 24 Crest of wall with gap behind the capping beam

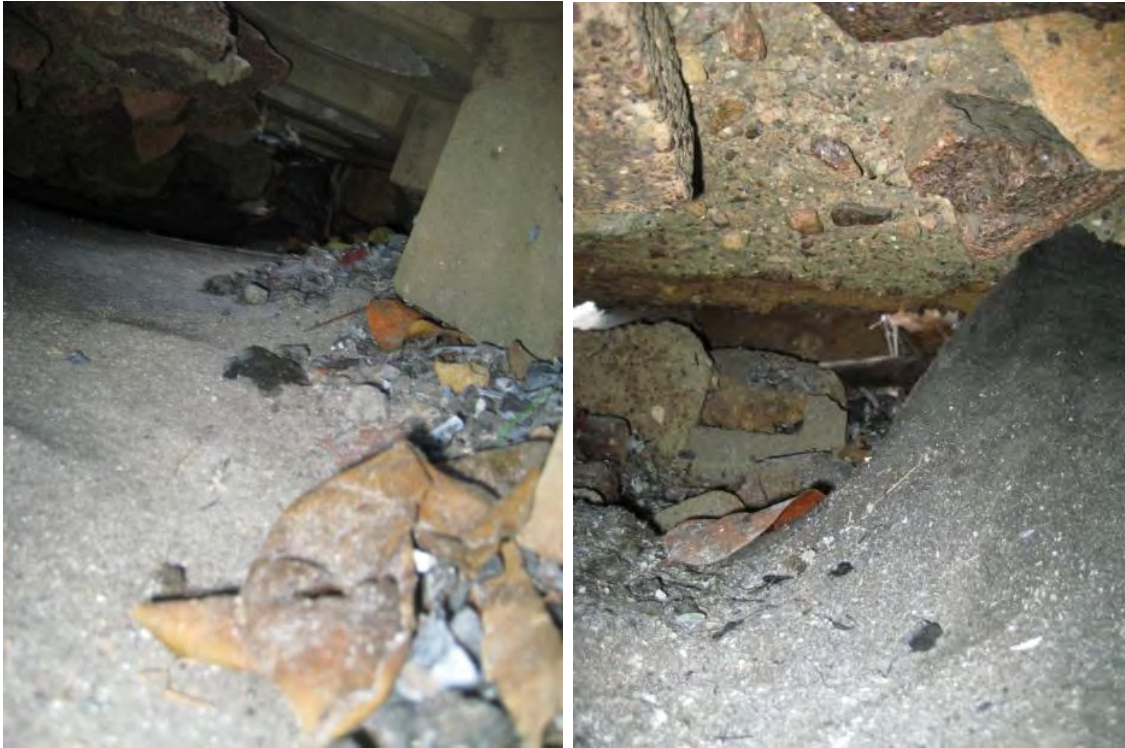
Figure 25 Beneath armour; note Seabee settled onto sand (l) & Figure 26 capping beam undermined (r)

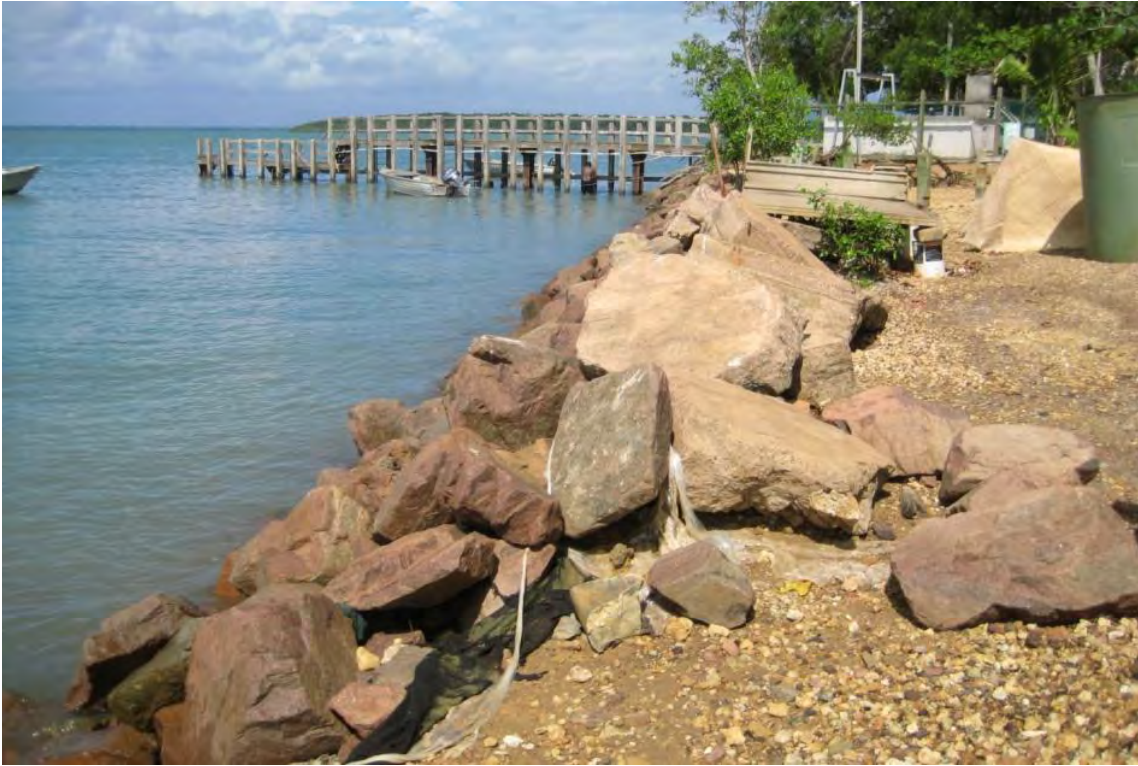
Figure 27 At a gap in the inadequate seawall looking east towards jetty

If the land cannot be raised then armouring of the crest of the seawall with large rock that will remain in place under overtopping waves will be required to stabilise the seawall and backing land.

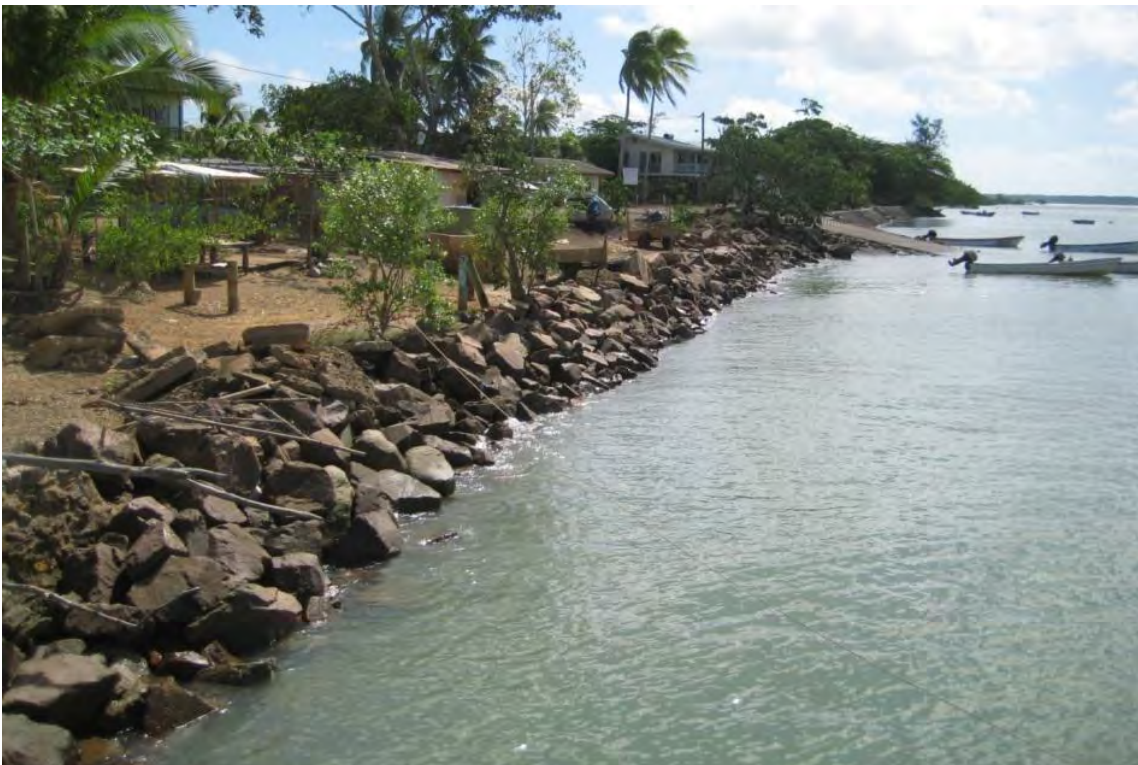
Figure 28 Inadequate seawall looking west towards boat ramp (note mangrove trees behind seawall)

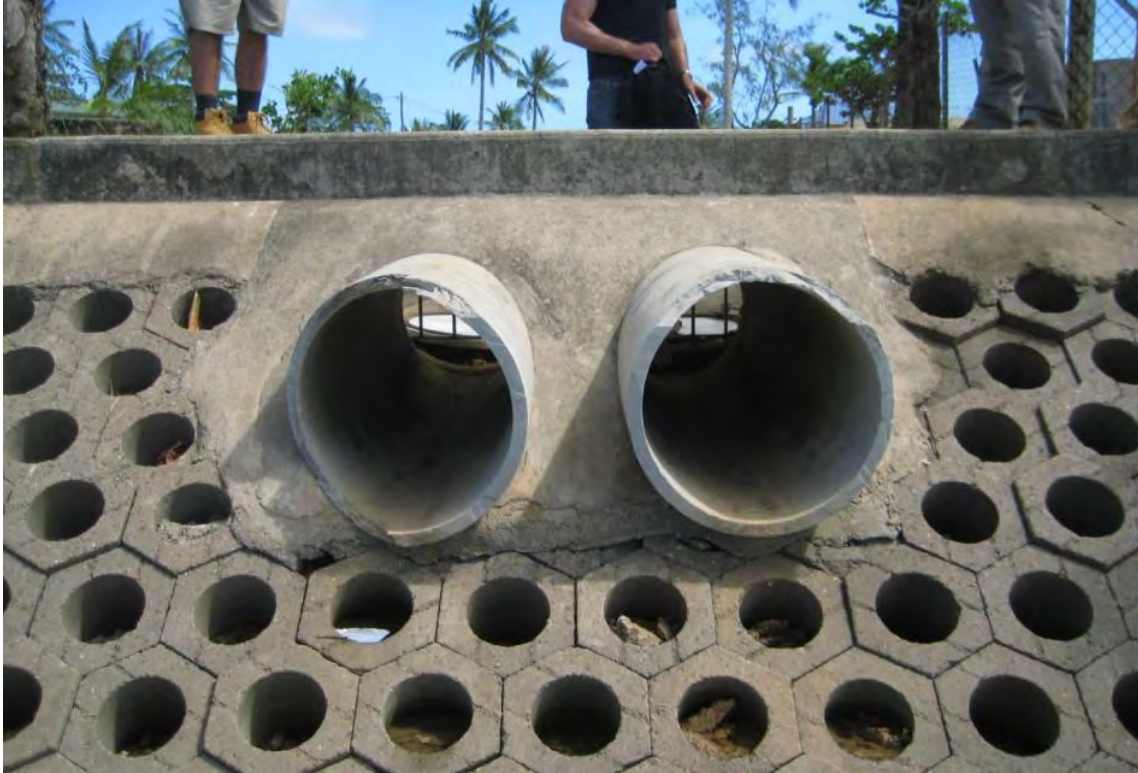
Figure 30 Drains through seawall have lost gates and allow back flooding.

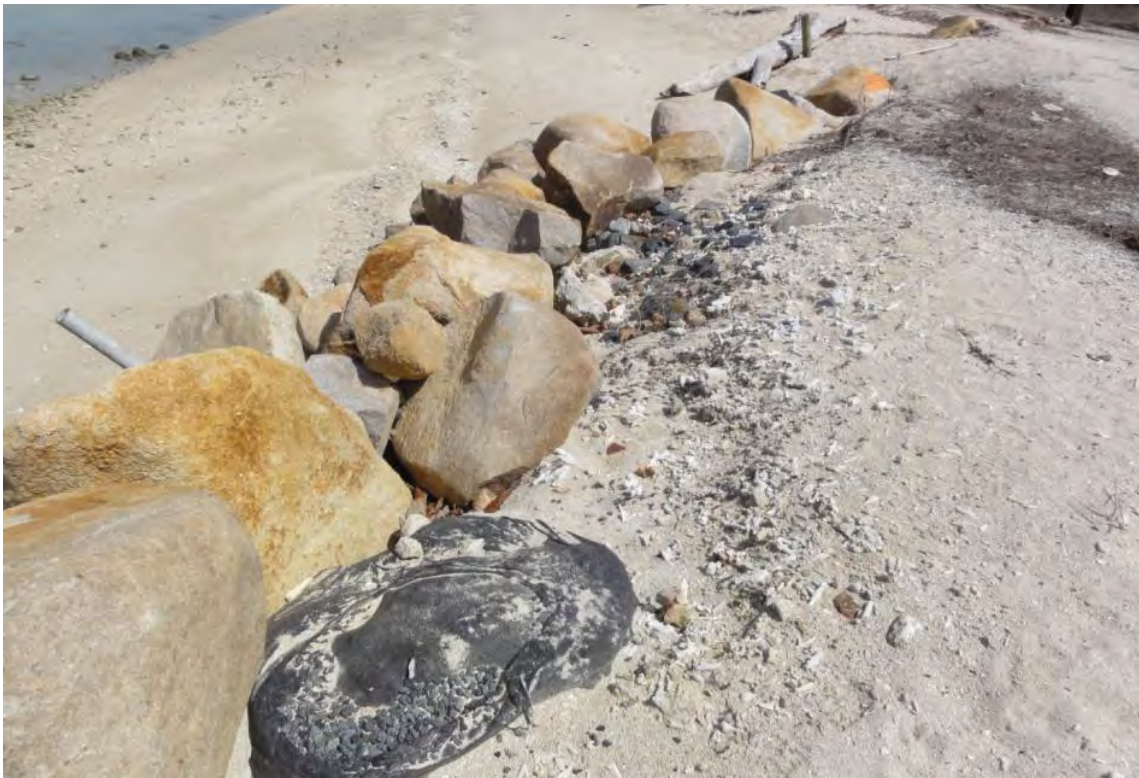
It was stated that the wall has not been properly founded and may be vulnerable to undermining during severe beach scour at the southern end of the beach. Because the seawall is too steep and the toe is not properly founded the seawall is vulnerable, and sections of the structure have collapsed or slumped (refer Figure 35).

Figure 35 Slumped section of the seawall

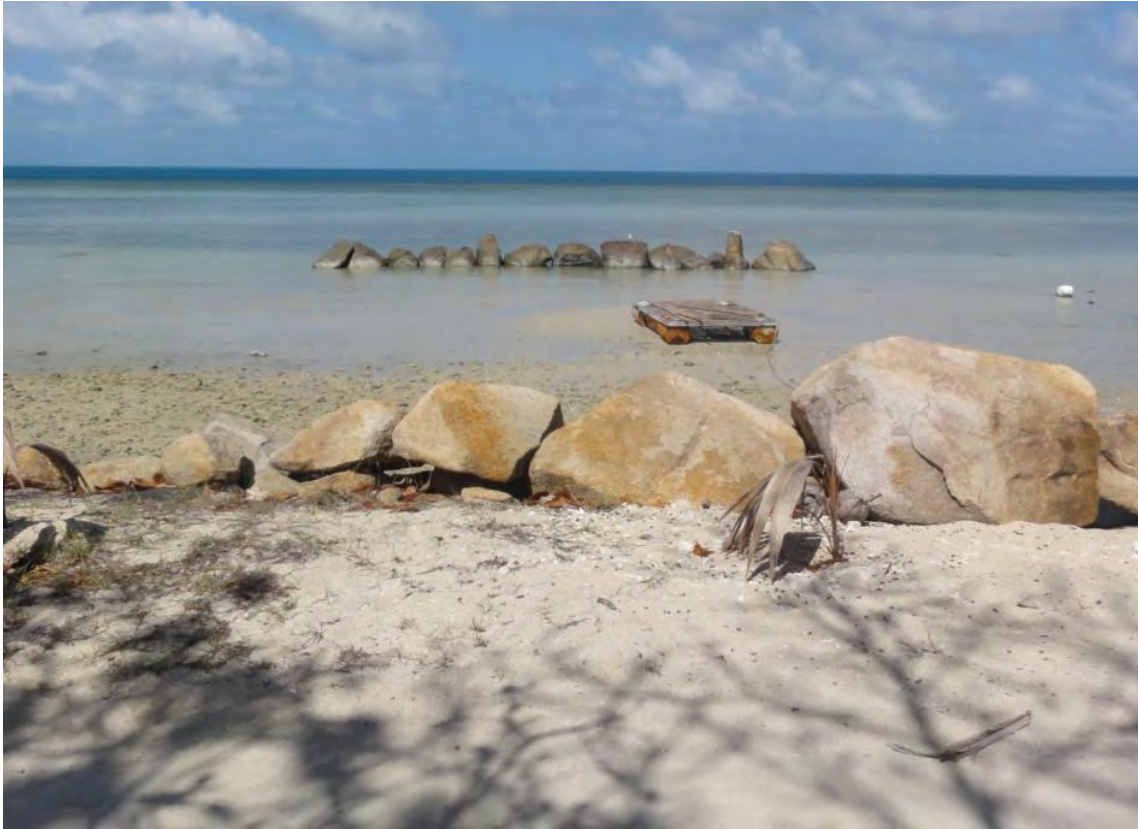
An offshore breakwater was constructed as a first attempt to protect the road (refer Figure 36). This structure serves no purpose now, and should be dismantled.

Figure 36 Ineffective offshore breakwater

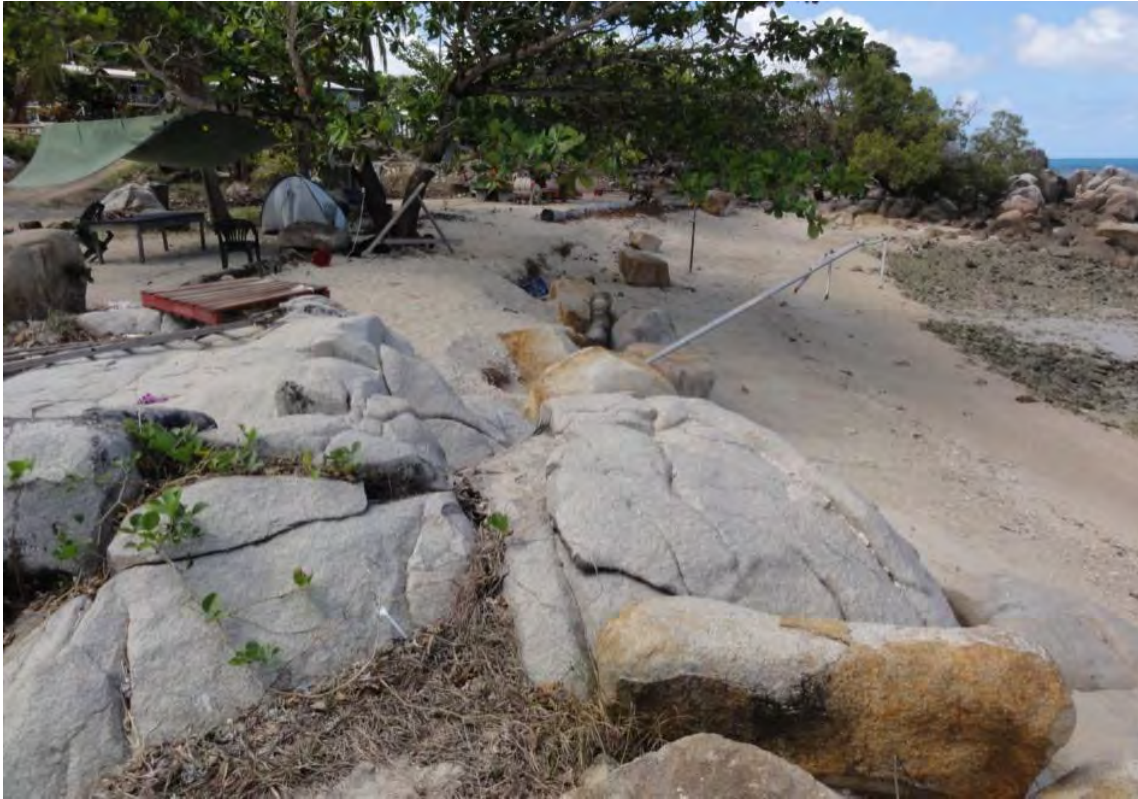
Figure 37 Erosion scarp at southern end of South beach (note native terrestrial rock in foreground)

If the community is concerned about the erosion then the use of vandal resistant geotextile bags filled with local sand supplies would be an appropriate defence solution. Should this work be undertaken it would be best if it were timed to be completed just before the NW monsoon commences. This would allow the work to be constructed on the eroded face and ensure that the structure was typically buried.

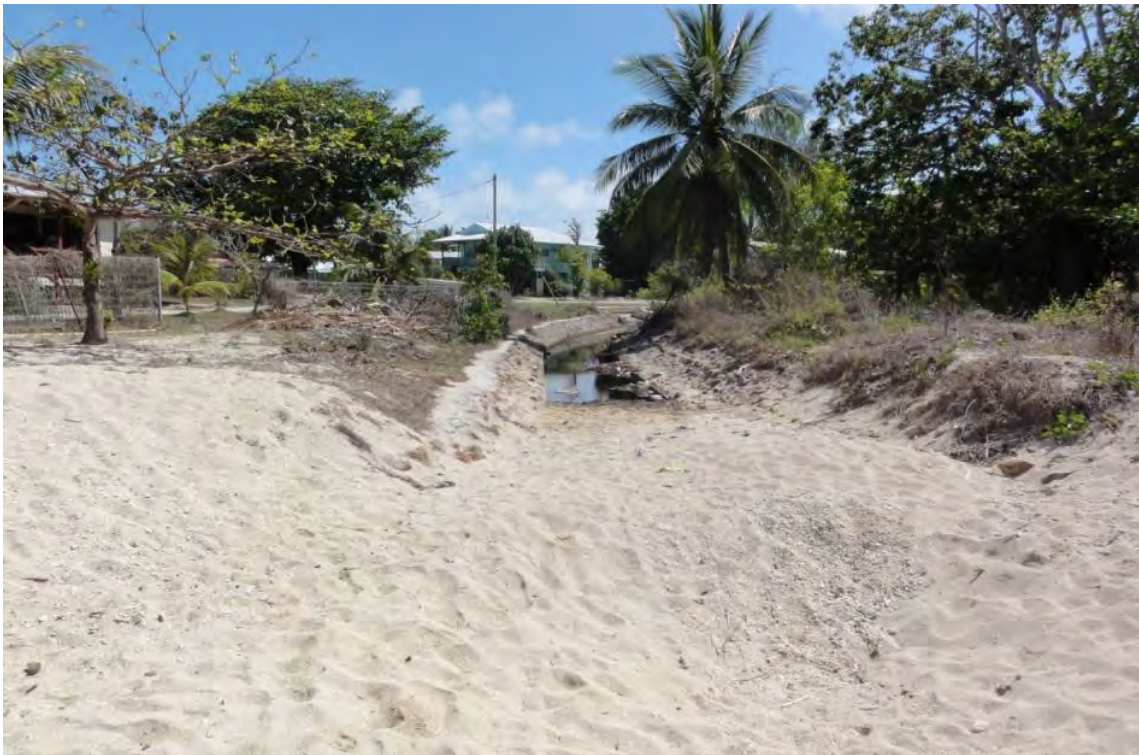
A lined drain discharges onto the rear of the southern beach. It was noted the drain near the beach was filled with sand and that the beach berm in front of the drain was higher than the drain (refer Figure 38). There was concern that the elevated beach levels prevented storm water from getting away.

Figure 38 Lined channel discharges onto beach

A culvert with a one way valve was discussed. This would require a culvert be dug into the beach and discharge onto the reef flats beyond the beach. It is felt at this stage that the need to construct of a culvert discharge requires monitoring. As a first step it is recommended that the drain be cleaned out to the lining. Where the drain discharges onto the beach a hollow should be dug out to allow water to pond and drain into the sand. The end of the drain and the hollow should be cleaned out regularly, with a clean out at the start of the NW monsoon being a minimum requirement.

If water levels behind the beach berm are an issue a channel can be dug through the beach berm to allow water to escape. Once water levels have dropped sufficiently the beach berm should be reinstated from material washed down the beach.

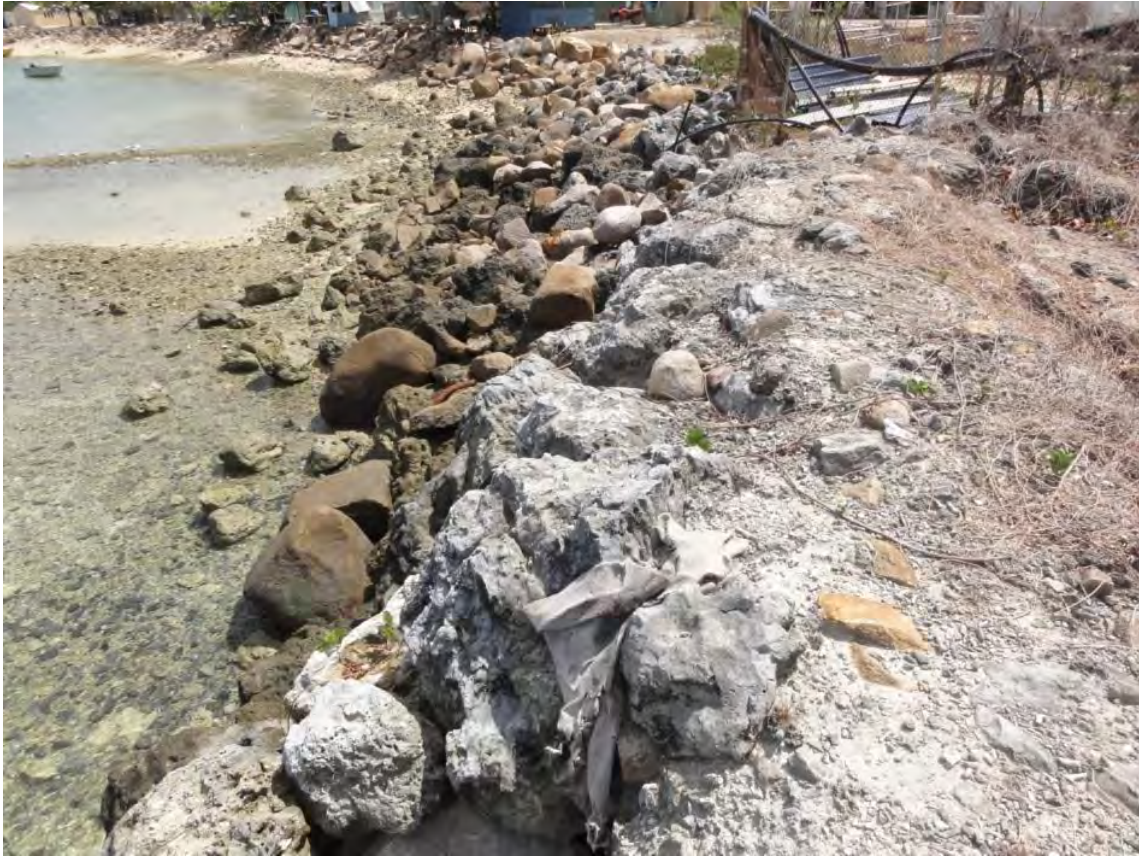
Generally the seawall around the desalination plant is in good repair (refer Figure 40). On the northern side however the quality of the construction is diminished (refer Figure 41), with a very steep wall transforming into a low poorly formed seawall heading towards the northern beach. This section of seawall is generally inadequate for a structure protecting high value assets.

Figure 41 Northern part of seawall protecting Desalination Plant (looking north), very steep in foreground.

For this length of seawall it is recommended that the seawall be topped up with suitable rock armour laid at a slope of 1 in 1.5 (similar to the units near the boat ramp).

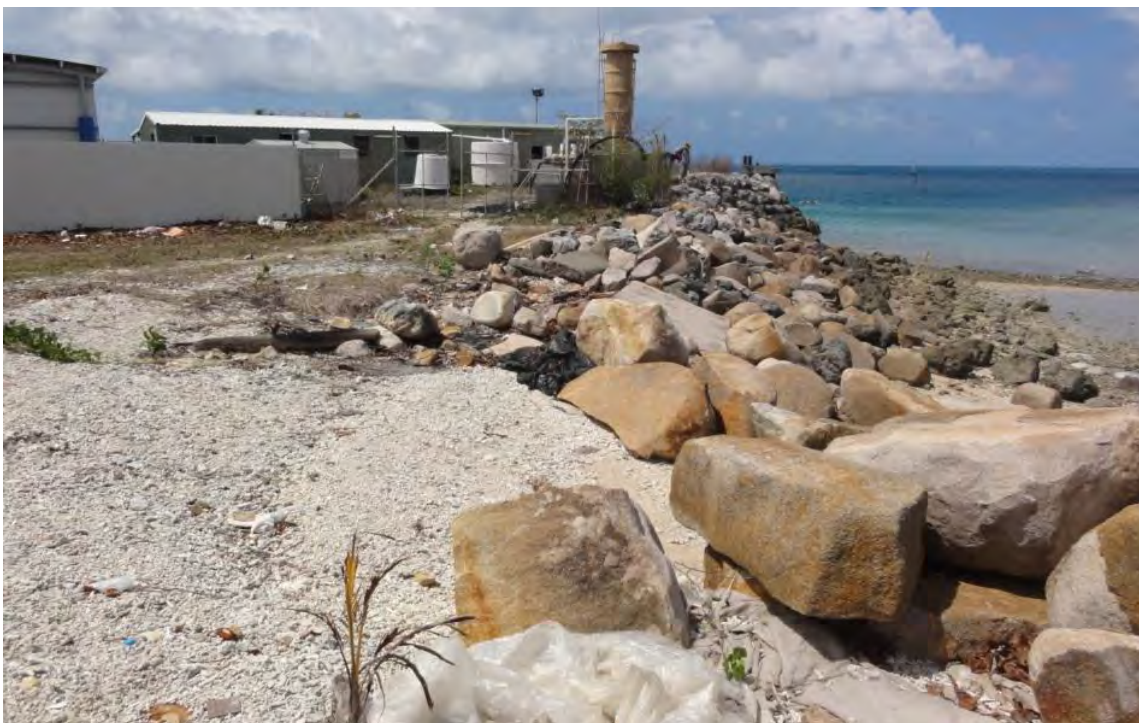
At the northern end of this section of seawall there is a particularly poor section of seawall that appears to be located at the site of an old boat ramp (refer Figure 42). The section of seawall does not appear to contain a filter layer or geotextile layer to confine the sediments. Here the armour needs to be dismantled and rebuilt using a filter layer and suitable armour at a slope of 1 in 1.5.

Figure 42 Northern part of seawall protecting Desalination Plant with low section in foreground (looking south)
