INUNDATION MANAGEMENT ON SAIBAI, BOIGU AND IAMA ISLANDS

Drainage and Seawalls

September 2012

Prepared for the Torres Strait Regional Authority by AECOM

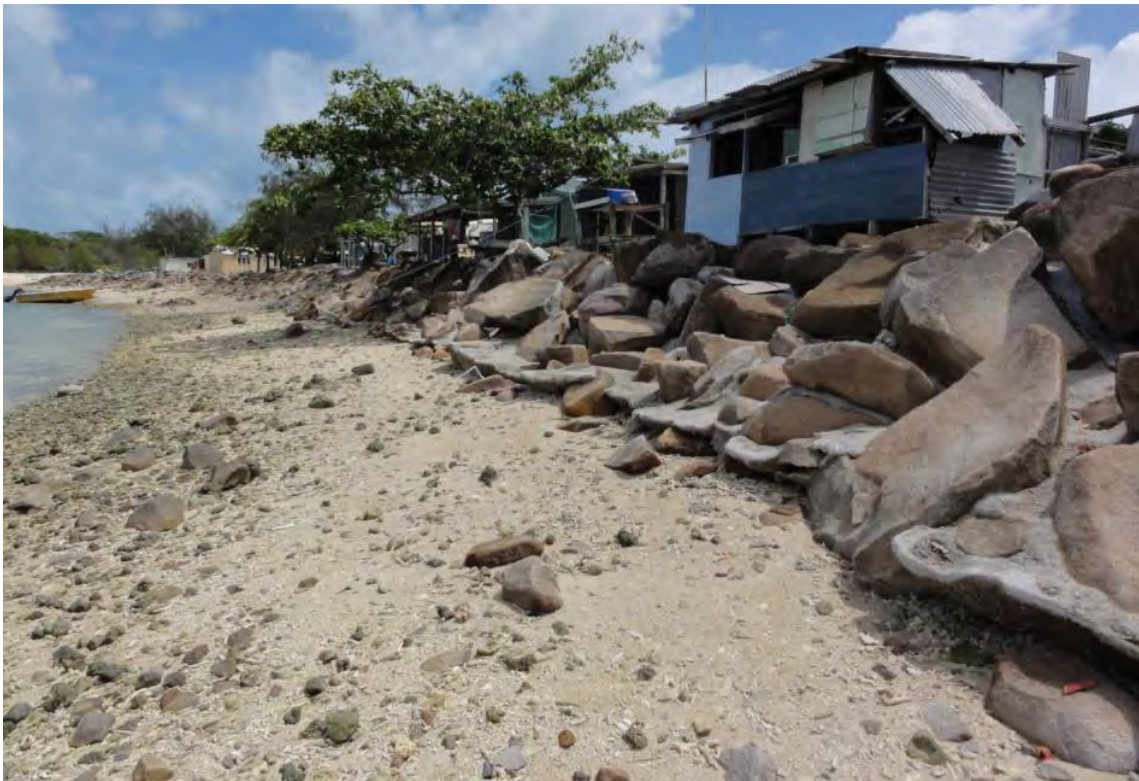
As discussed above the northern beach is suffering from a loss of sand supply and as a result is eroded. A seawall has been constructed to protect the spit and over the years this has been “reinforced” with concrete. The beach erosion has resulted in some undermining of the seawall (refer Figure 42). The seawall construction deteriorates towards the north of the structure (refer Figure 45).

Figure 44 Northern beach seawall undermined by beach erosion.

If habitation of the area is to continue, the seawall needs to be reinforced/repared and a wave return wall constructed to exclude the high tide waves that occur. This work would require additional toe armour to be placed along the length of the seawall to stabilise the structure from undermining and the repair of the crest of the structure. A wave return wall, with special toe detailing to protect against scour of material in front of the wall would occupy the first metre or so of land behind the armour and will require the relocation/removal of structures built close to the foreshore (refer Figure 44 and Figure 48) and some mature trees. On the eastern side of the spit the construction of an earth embankment with a crest height approximately 0.5m lower than the wall can exclude inundation from that direction.

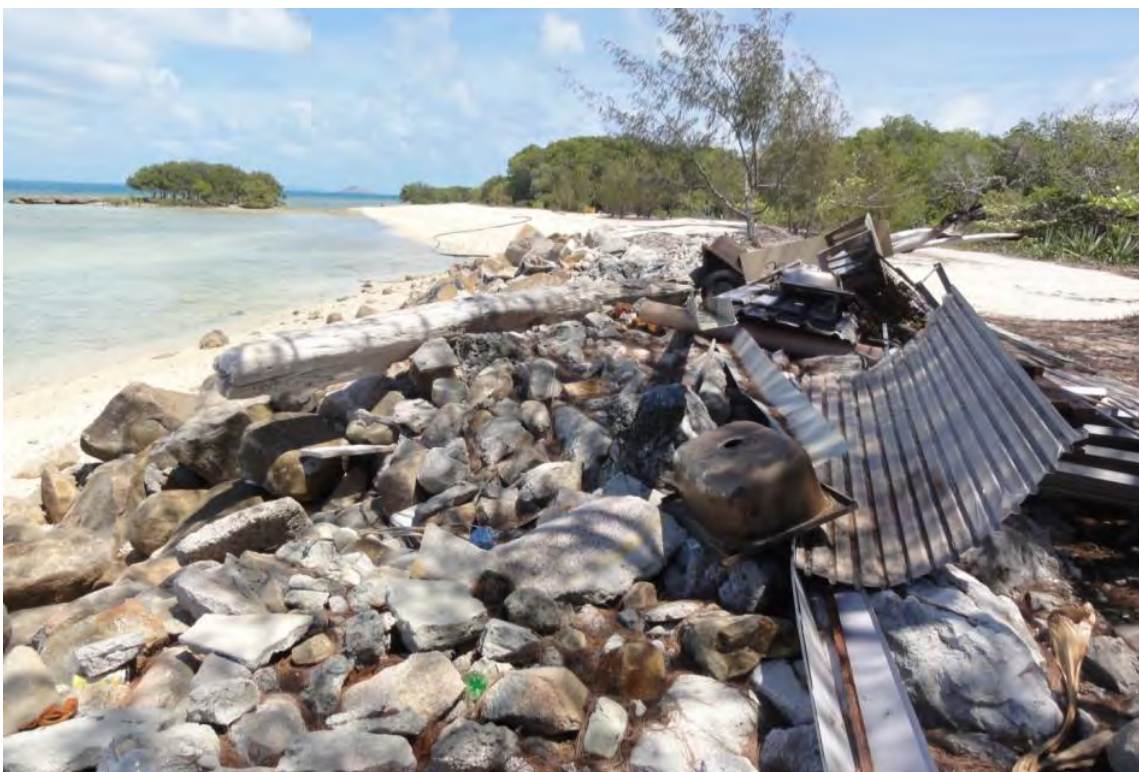
Figure 45 Northern end of seawall (note rubbish piled up to reinforce seawall crest)

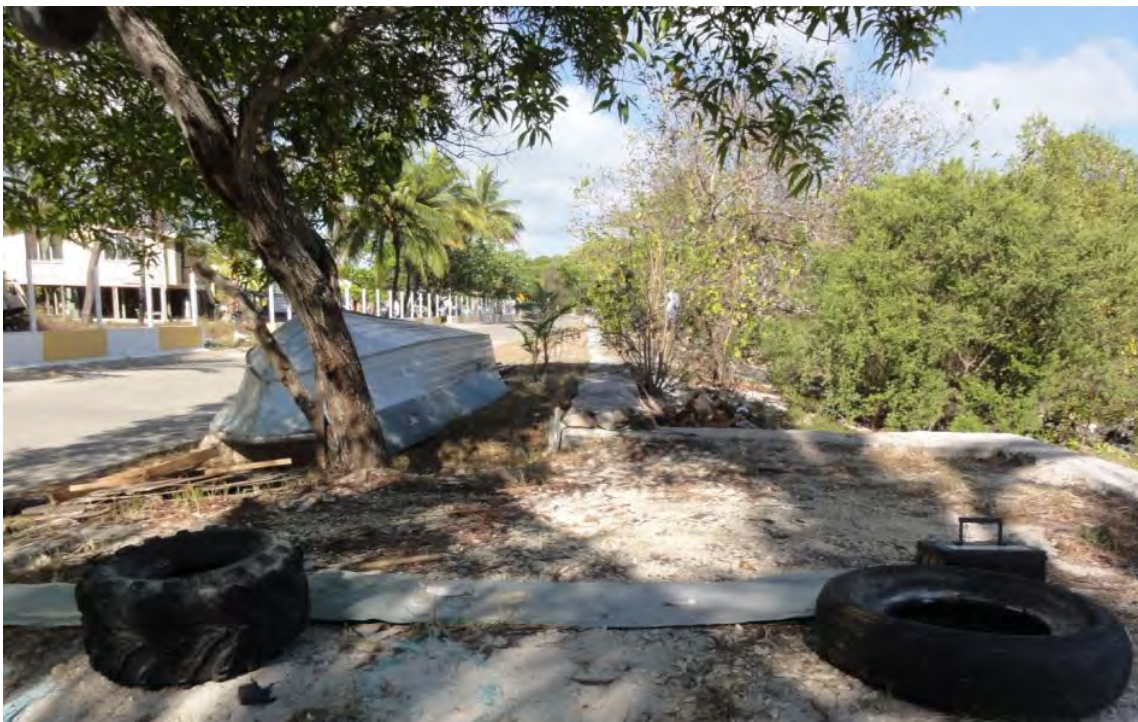
Related to the boat ramp is the vulnerability of the second and more substantial wall (painted yellow and white) because of the gaps left in the wall for vehicular access. These gaps are blocked with sand bags when the risk of flooding is high. A more permanent solution might be attractive to council. This could either be a ramped driveway that rises to a level equivalent with the wall or the provision of light weight gates that can be dropped in place.

Figure 50 Double line of defence, low wall facing mangroves and higher yellow/white wall protecting houses (I).
