INUNDATION MANAGEMENT ON SAIBAI, BOIGU AND IAMA ISLANDS

Drainage and Seawalls

September 2012

Prepared for the Torres Strait Regional Authority by AECOM

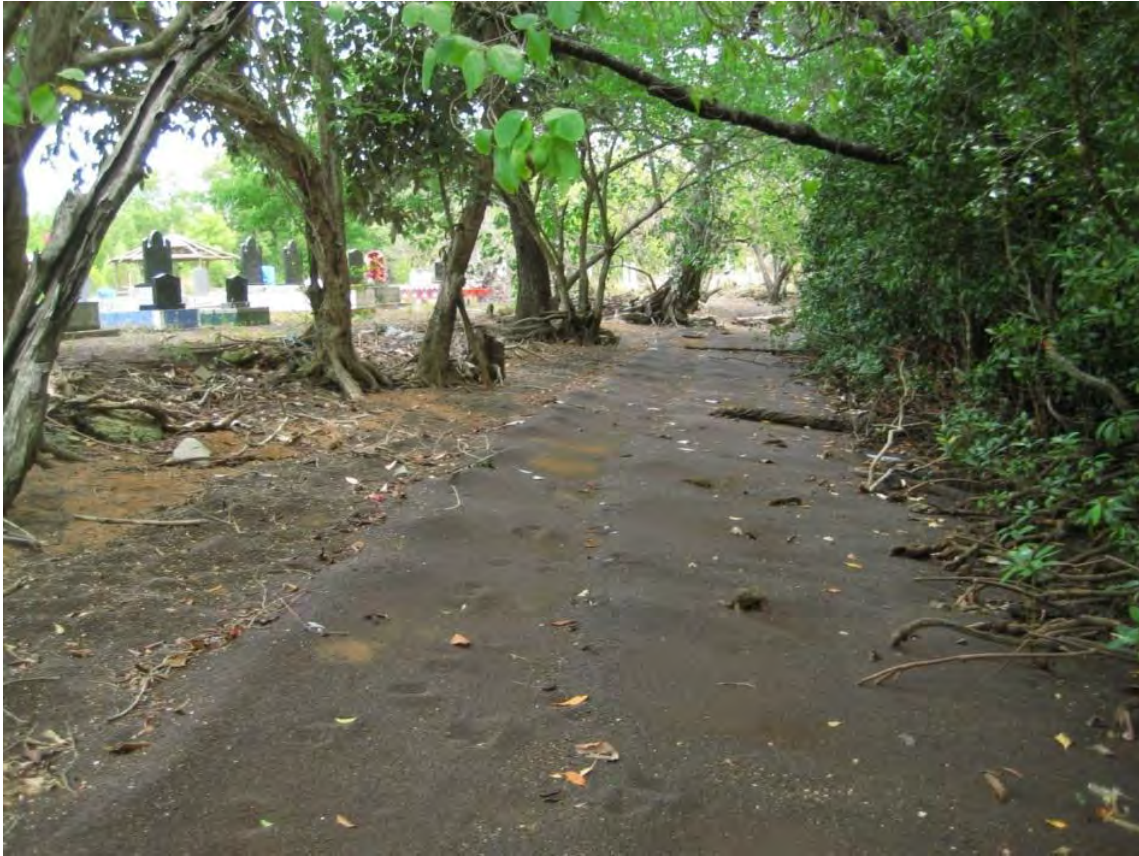
The natural coastline in the area would have consisted of a mangrove forest backed by a sandy beach that was pushed up by the limited wave energy that passed through the mangrove forests during high tides. Examples of this beach form can be found west of the sewage treatment plant (refer Figure 2).

Figure 2 Natural beach and mangrove foreshore (cemetery on left with mangrove forest on right)

As seen in Figure 2 there is some evidence that minor erosion on the upper beach, with tree roots exposed. To combat this minor erosion the use small rock armour along the crest of the beach is recommended. This is intended to be a flexible minor armouring solution that can stabilise the upper beach against small wave attack and currents.

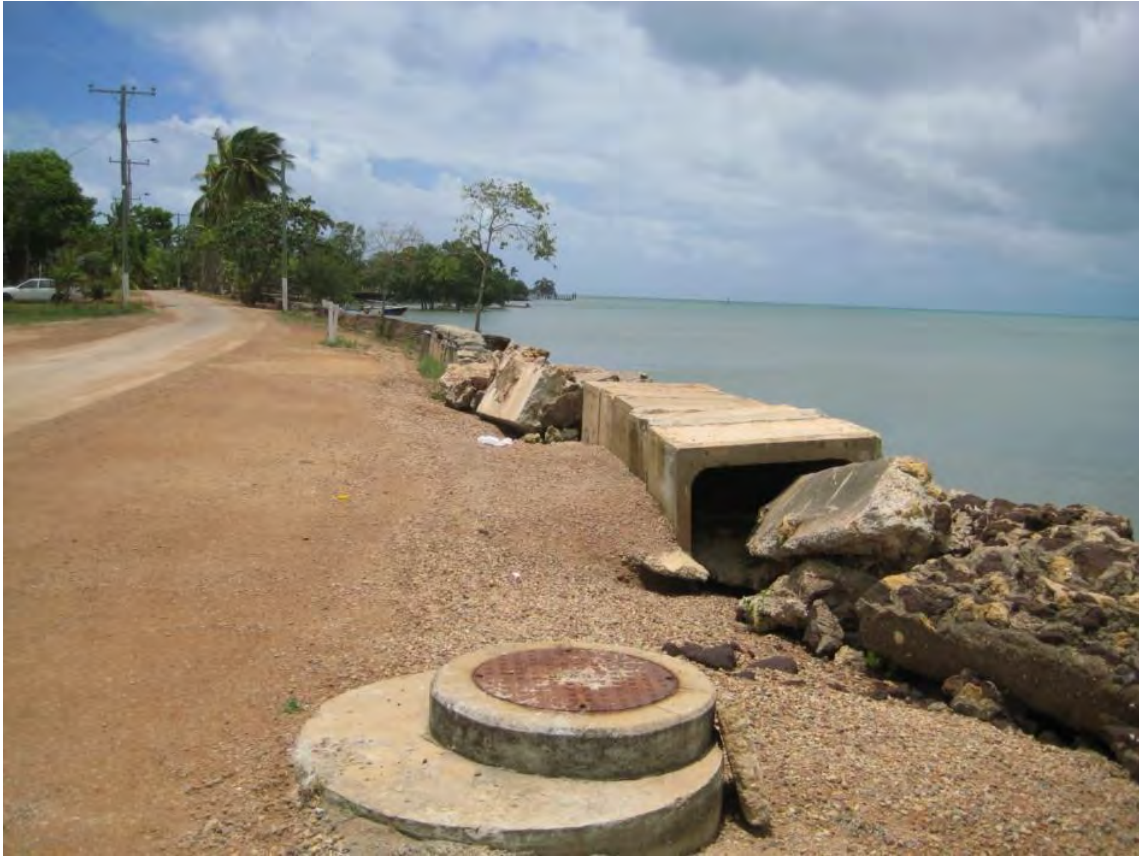
There have been some more significant inundation events over the years however as an indication of the problem observations made by Angus Gordon in February 2007 are presented in the series of comparative images from the site in Figure 12 to Figure 17. During this event the tide rose up to 3.9m LAT (2.2m above MSL).

Figure 12 Above the box culverts looking west 2nd November 2011

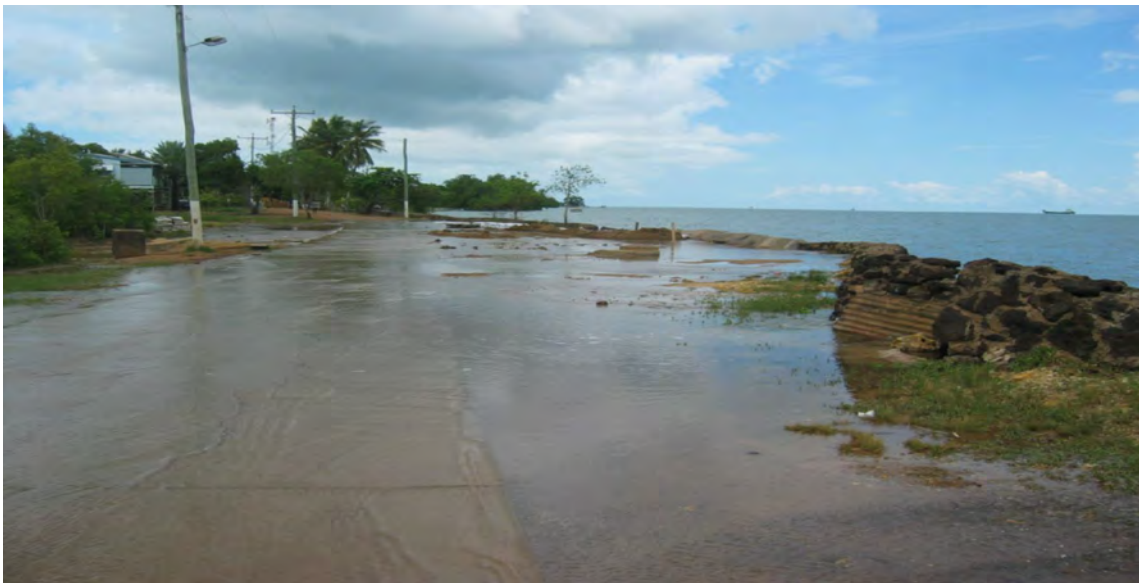
Figure 13 Looking west over the box culverts 16th February 2007

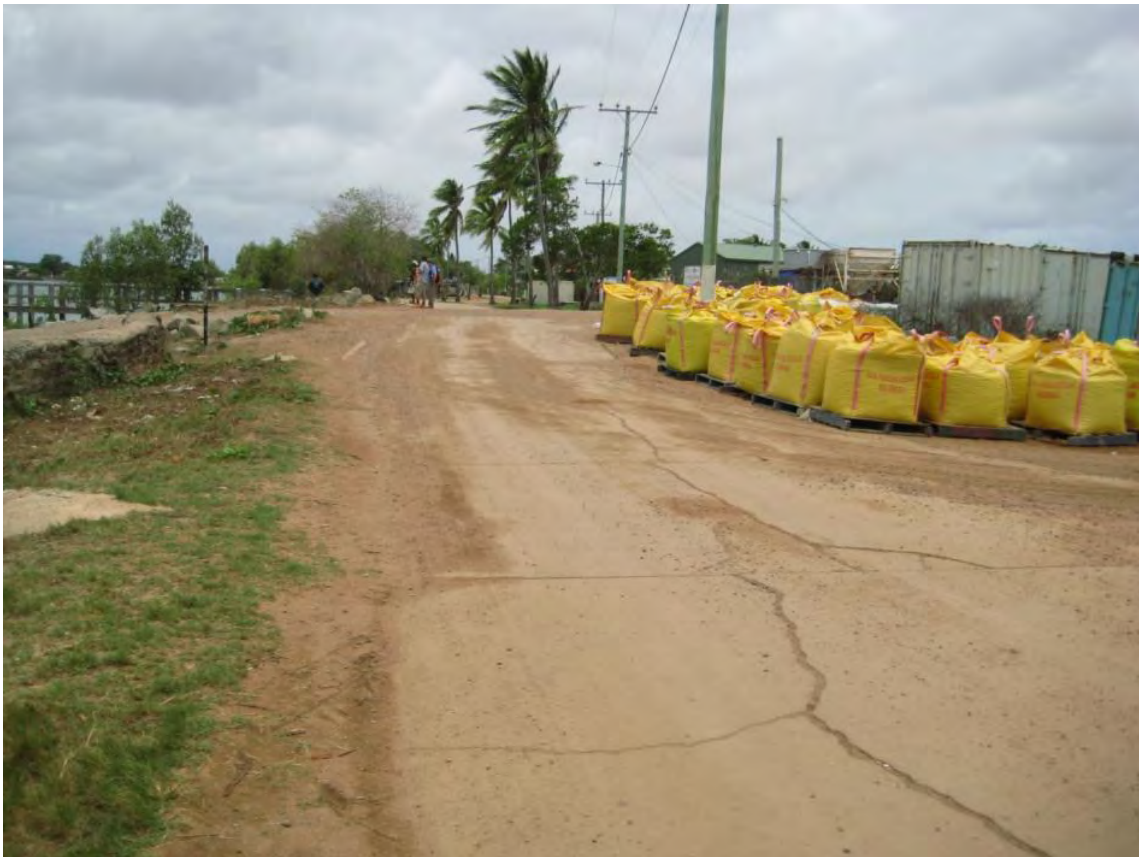
Figure 14 View towards jetty 2nd November 2011

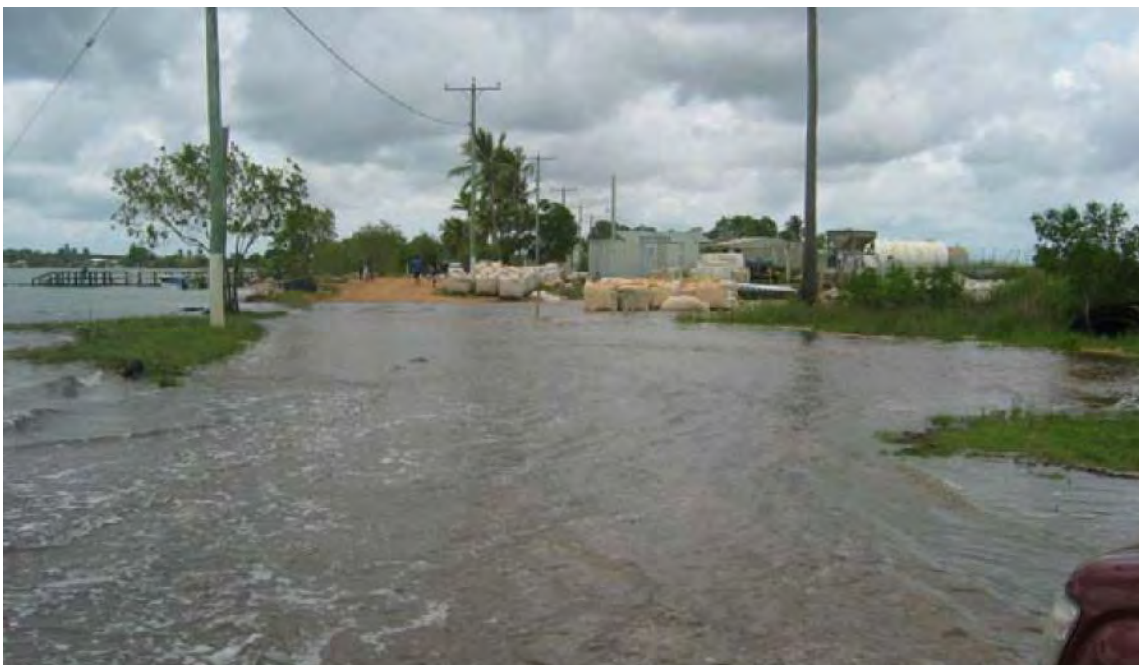
Figure 15 View towards jetty 16th February 2007

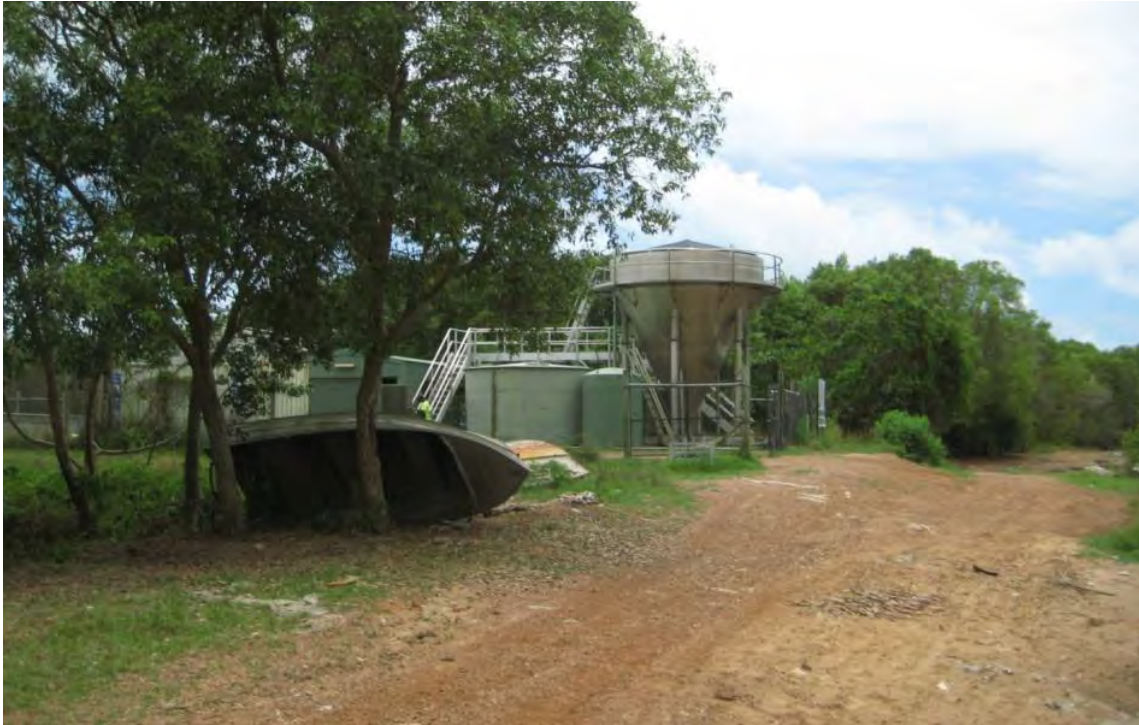
Figure 16 Sewage treatment plant 2nd November 2011

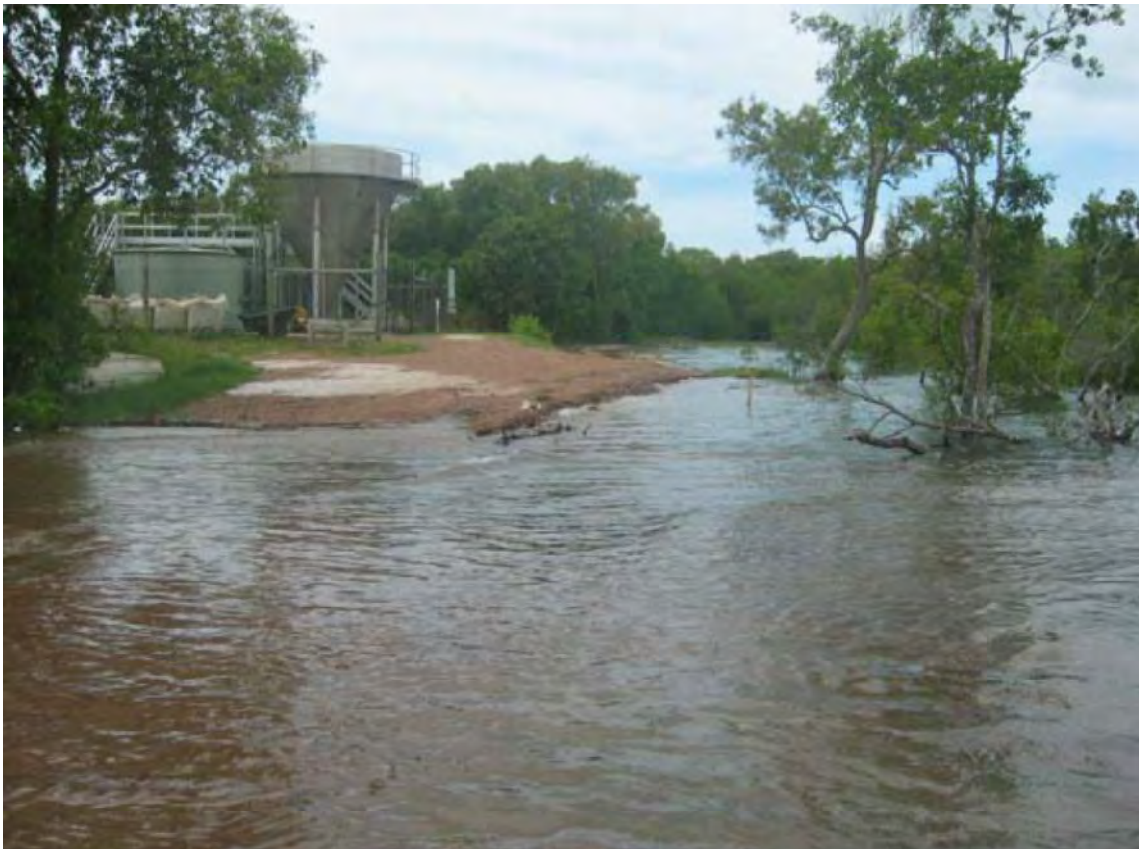
Figure 17 Sewage treatment plant 16th February 2007

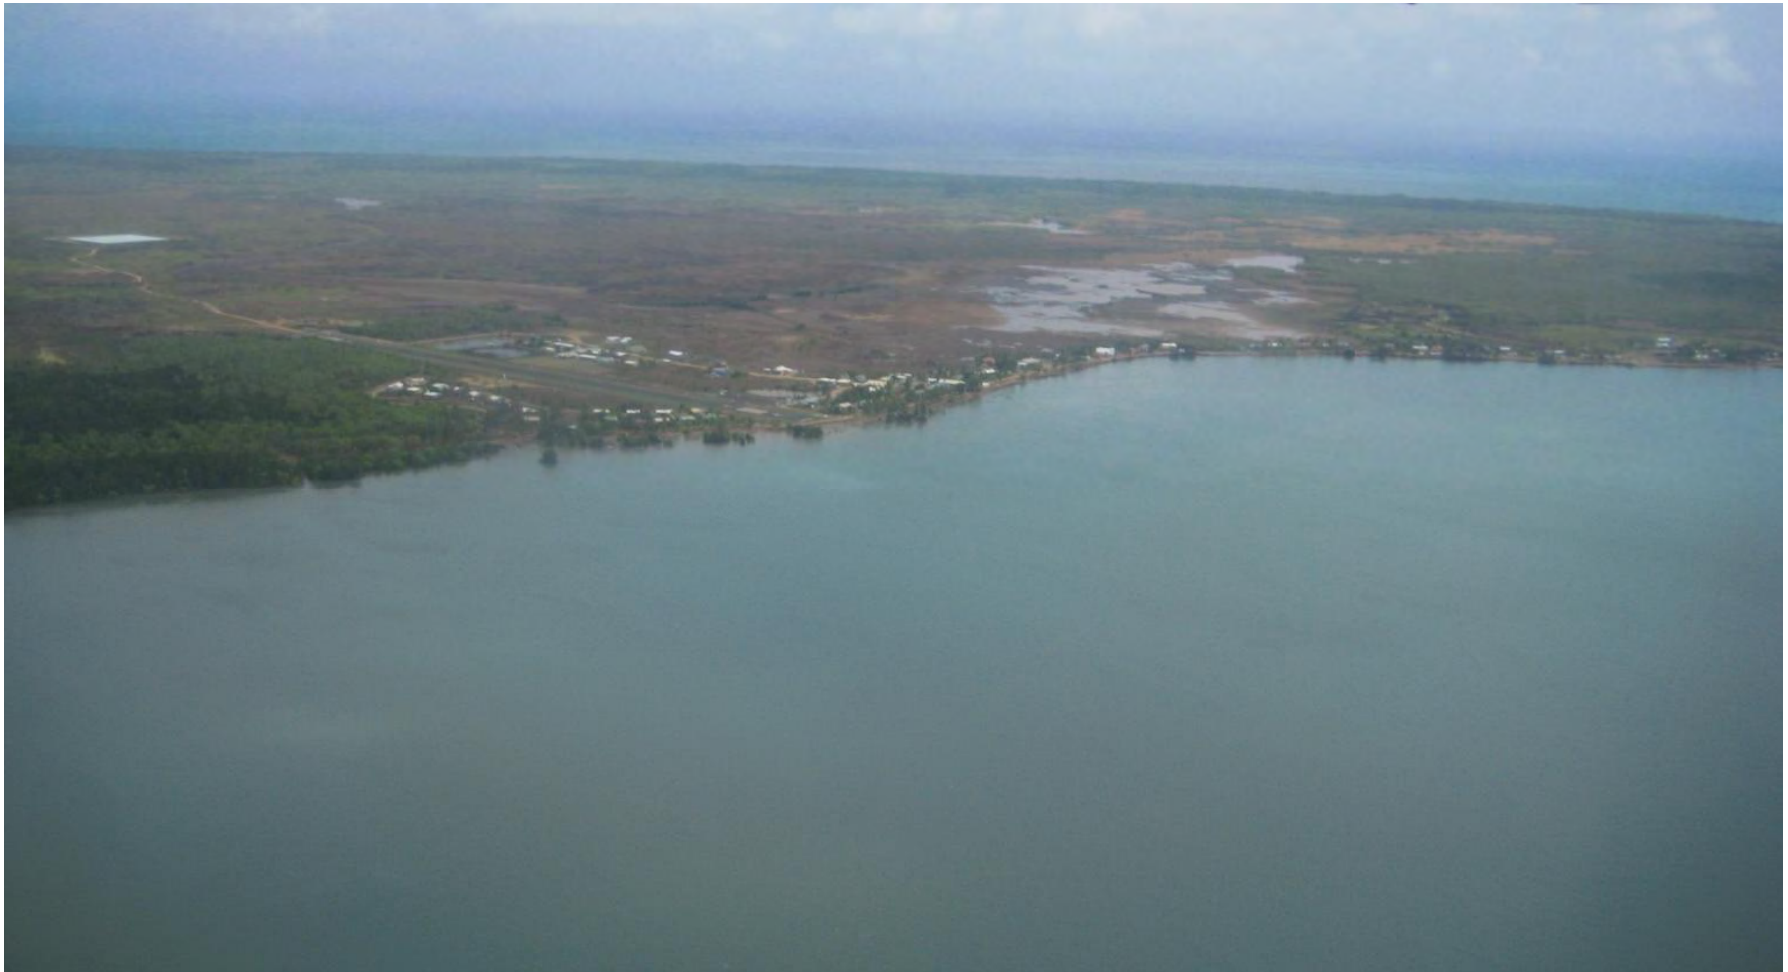
Many locals commented on inundation coming in from both sides (refer Figure 18). That is the community was flooded from both the sea and the wetlands. Angus Gordon during his visit made comment on the apparent mechanisms in play with this inundation. In summary Angus noted that the inundation from the wetland was not a problem initially but that the level in the wetland built up during the spring tides, and flooded land towards the end of the spring tide cycle. He concluded the high roughness in the system impeded marine infilling and that it took a number of high tide levels to “pump up” the wetlands. He also noted that the peak in wetland water levels occurred some hours after peak tide levels. This indicates that the peak water levels in the wetland are below those of the ocean. At this stage no recorded data exists to confirm this theory nor is there any data on how exposed the community is to flooding from the wetlands.

Figure 18 Saibai - Between the sea and the extensive wetland that are connected to the sea through the mangroves and channels (looking south)

To reduce the risk of flooding in the community inflows into the wetlands during spring tides should be kept to a minimum, while outflows should be maximised. This could be achieved by the use of substantial one way valves in key locations.

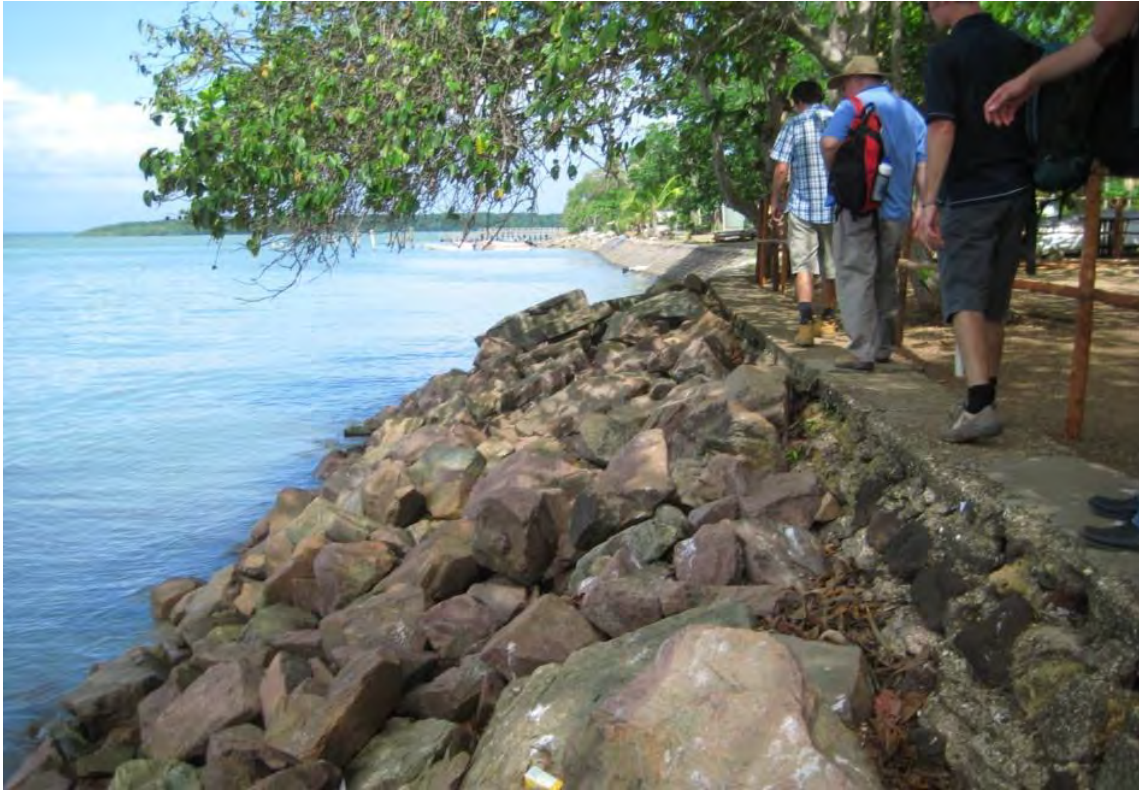
The seawalls protecting the foreshore of Boigu were generally in good repair and relatively well engineered, using geotextile, filter layers and suitably sized armour units. The seawalls were a mixture of conventional rock armour (refer Figure 20) and pattern placed Seabee units (refer Figure 21).

Figure 20 Rock armour seawall built over a relic block work wall

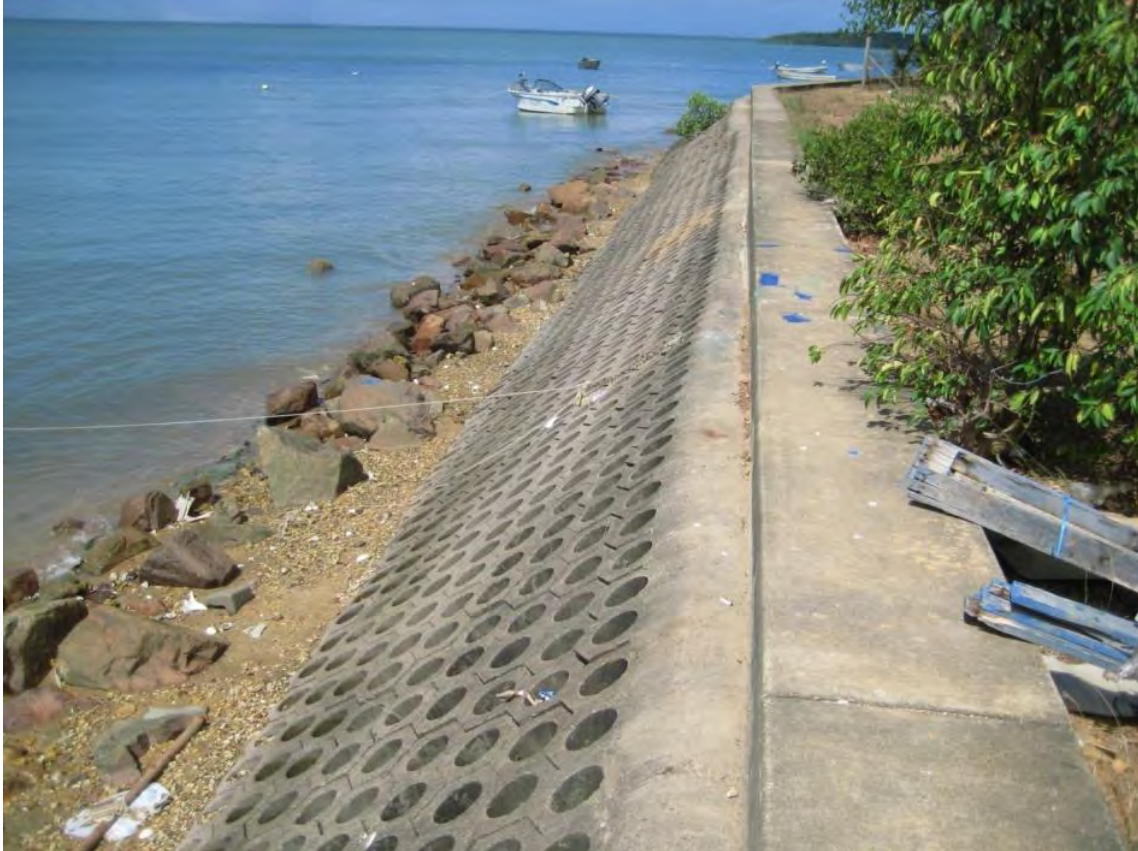
It is understood from design drawings for this seawall that the toe of the Seabee seawall was buried approximately 0.5m into the existing sandy bed and may not be founded into the coral platform. The design called up the use of rock protection on the toe though it is not clear if this was constructed. If there are doubts about the use of the armour on the toe during construction it would be prudent to armour up the toe of the structure to prevent the seawall being undermined. This can best be achieved by placing significant rock armour units on the toe of the structure. Some lengths of the Seabee seawall have an armoured toe (refer Figure 29).

Figure 29 Armoured toe for Seabee seawall.

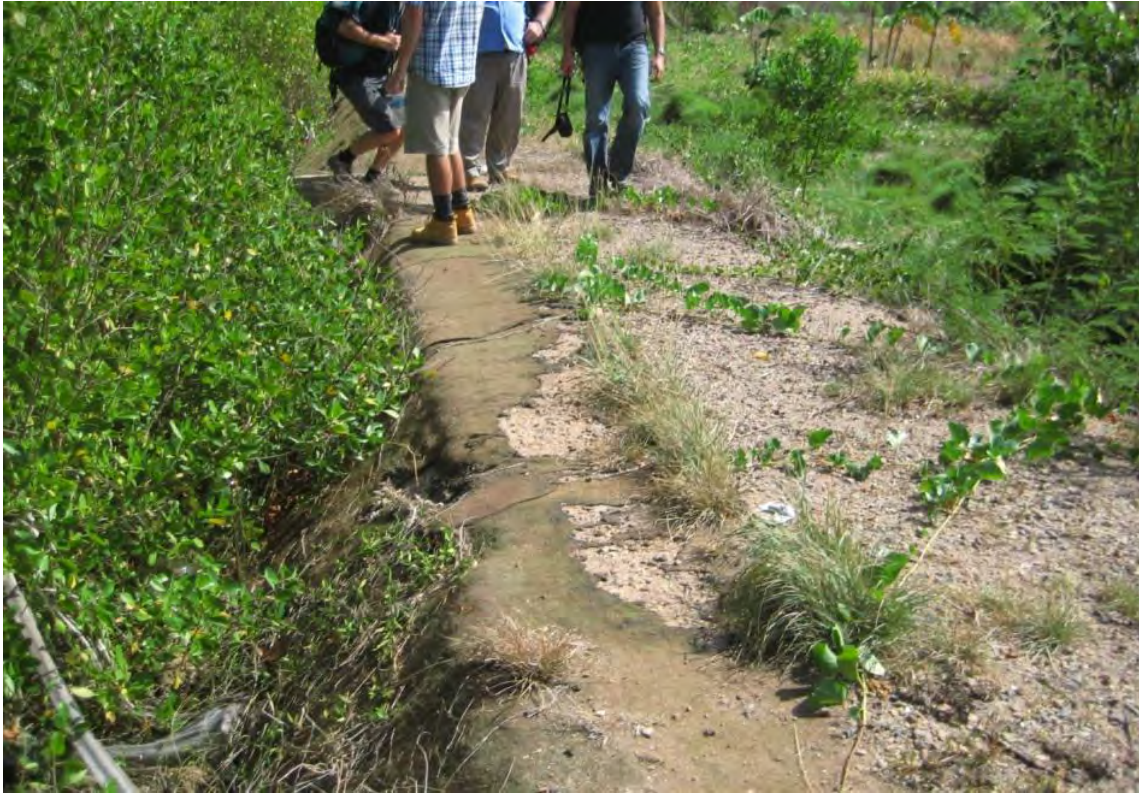
Drainage infrastructure was seen as an issue; allowing tidal water through the seawall and reducing the immunity of the community (refer Figure 30). The community is protected to the south from inundation through the mangroves and wetlands by the airport runway and a system of bund walls (refer Figure 31). Discussions with the school headmaster indicated there was a considerable amount of standing water within the community area, especially during larger tidal events. It appears that ocean water is back flowing past the tide flaps and inundating the lower lying areas of the community. This indicates that the flaps installed on the 2/1200 x 450 RCBC are not entirely effective. It is therefore recommended that the council inspect and replace the valves in the bund as required. This should preferably occur prior to the next king tide event.

Figure 31 Bund wall at the eastern end of the community.

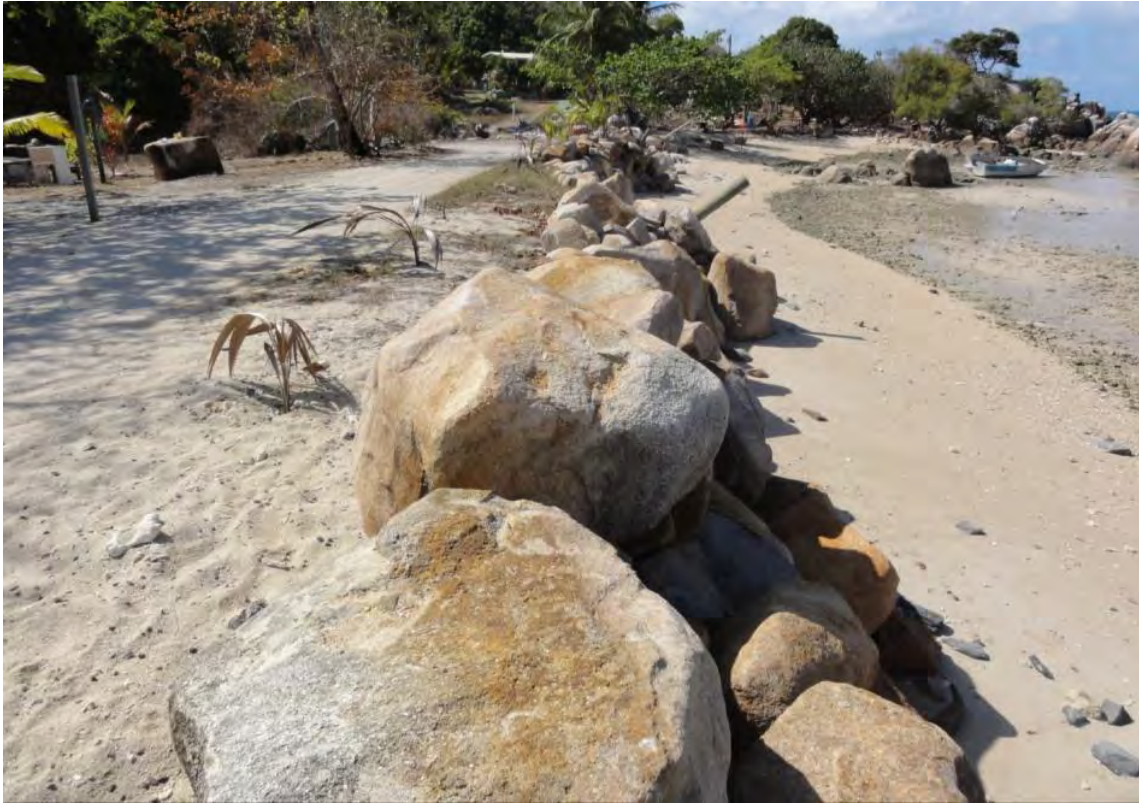
Near the southern end of the beach a seawall has been constructed to protect a road that extends out onto the edge of the beach at that location (refer Figure 34). The seawall is required because the road has been constructed too close to the active beach profile and not because of any ongoing coastal erosion issue in the area. Examination of cadastral lines indicates that this road is a recent construction. The seawall has not been designed by an engineer and has been constructed at a very steep slope. Despite this fact the seawall was constructed using a geotextile filter and the blocks were carefully laid resulting in a functional seawall.

Figure 34 Road protected by seawall

The seawall needs additional armour to flatten the slope of the front face to a more stable 1 in 1.5. The additional armour placed on the front face should extend at least 1m below the current beach level or to the reef platform, whichever is encountered first to stabilise the toe of the structure.

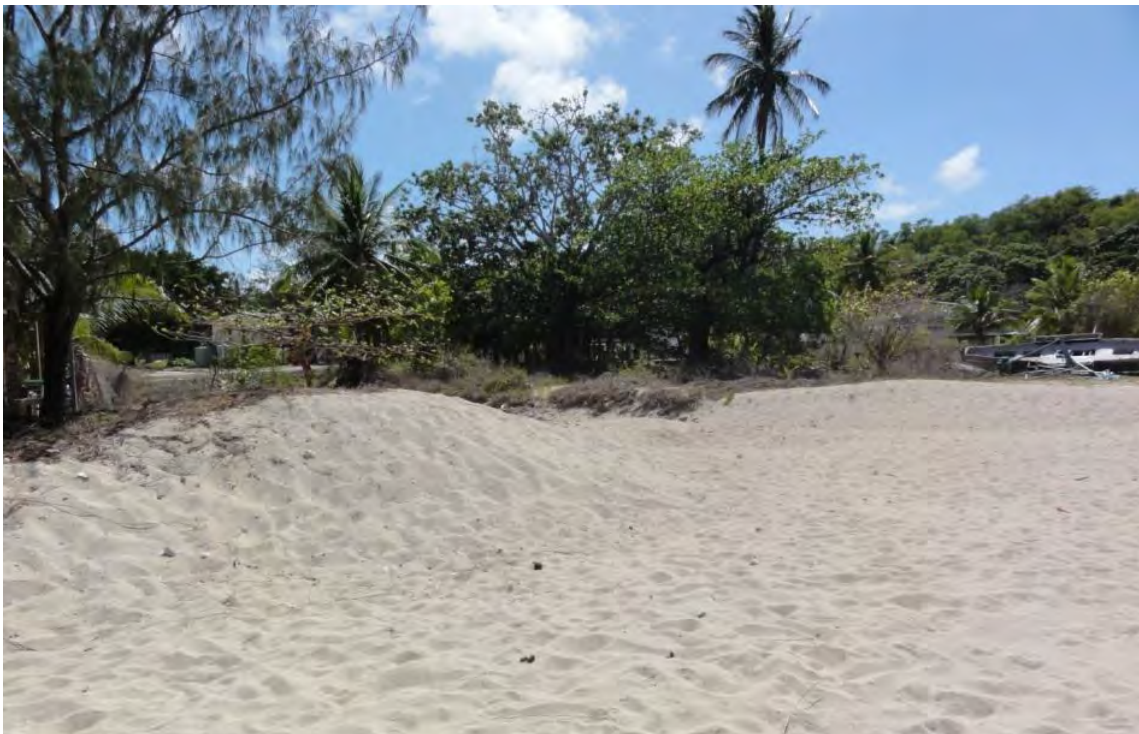
The beach berm serves a vital role in keeping tidal and storm water out of the community and needs to be preserved to protect against inundation. The berm in front of the drain was slightly lower than in other areas of the beach (refer Figure 39). Care should be taken to ensure that the berm here is restored to a level consistent with the rest of the beach to provide appropriate immunity.

Figure 39 Lowered beach berm at entrance where drain discharges

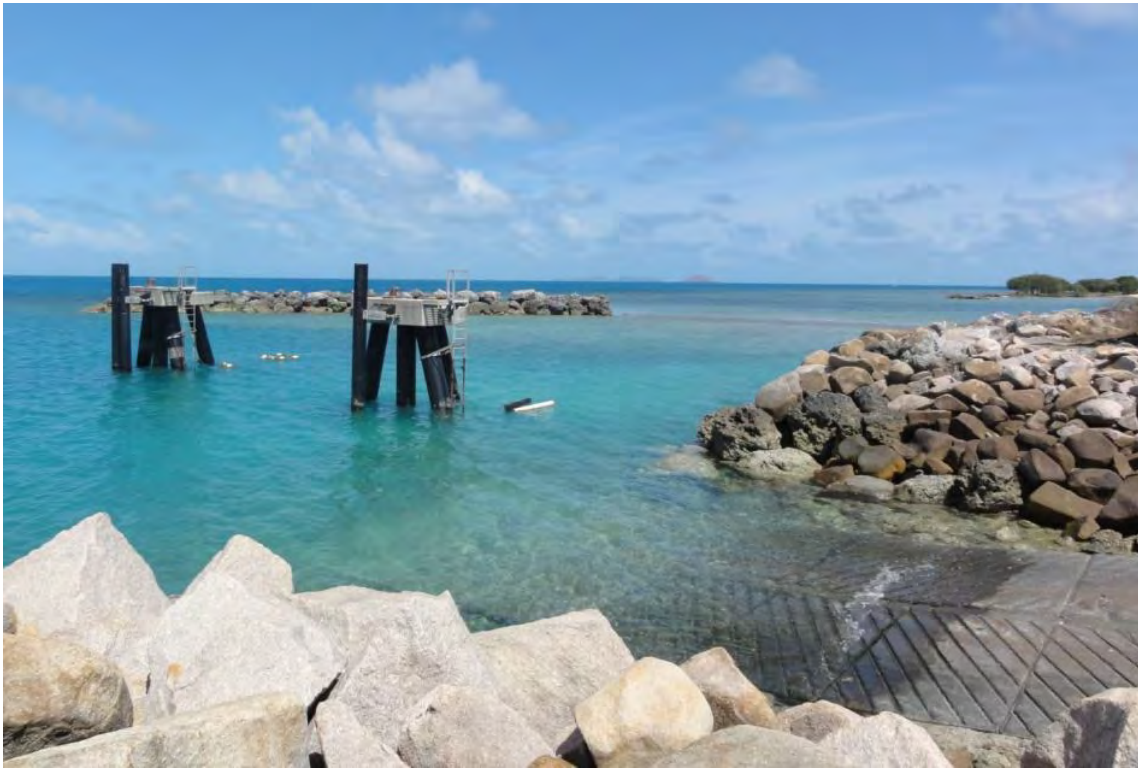
Generally the seawall around the desalination plant is in good repair (refer Figure 40). On the northern side however the quality of the construction is diminished (refer Figure 41), with a very steep wall transforming into a low poorly formed seawall heading towards the northern beach. This section of seawall is generally inadequate for a structure protecting high value assets.

Figure 40 Seawall protecting desalination plant with offshore breakwater in background (looking north)

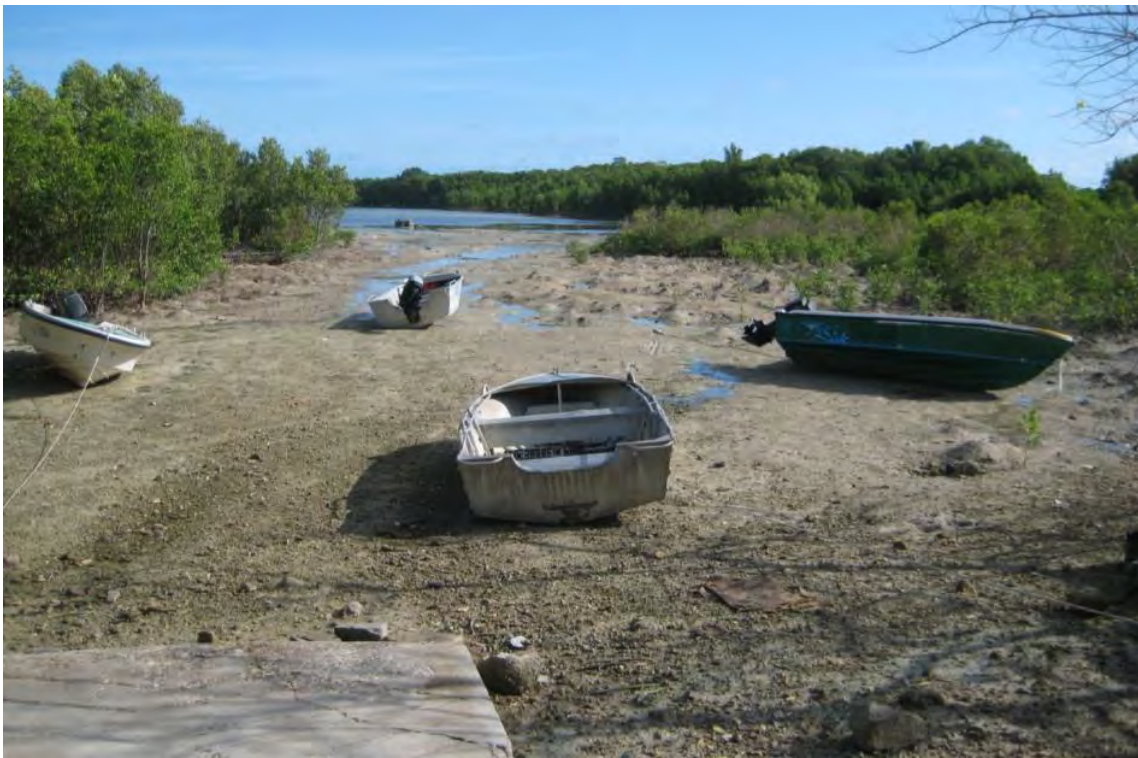
During a meeting with local council personnel the issue of safe landing at or near the boat ramp during the NW monsoon was raised. It was claimed that the offshore breakwater (refer Figure 40) is not proving sufficient protection and that as a result people are sailing around the spit and using the high tide boat ramp in the mangroves (refer Photo 42). It was noted that doing this at night was a safety issue.

Figure 43 High tide boat ramp in mangroves sheltered from NW waves (note tide was 0.3m above MSL in photo)

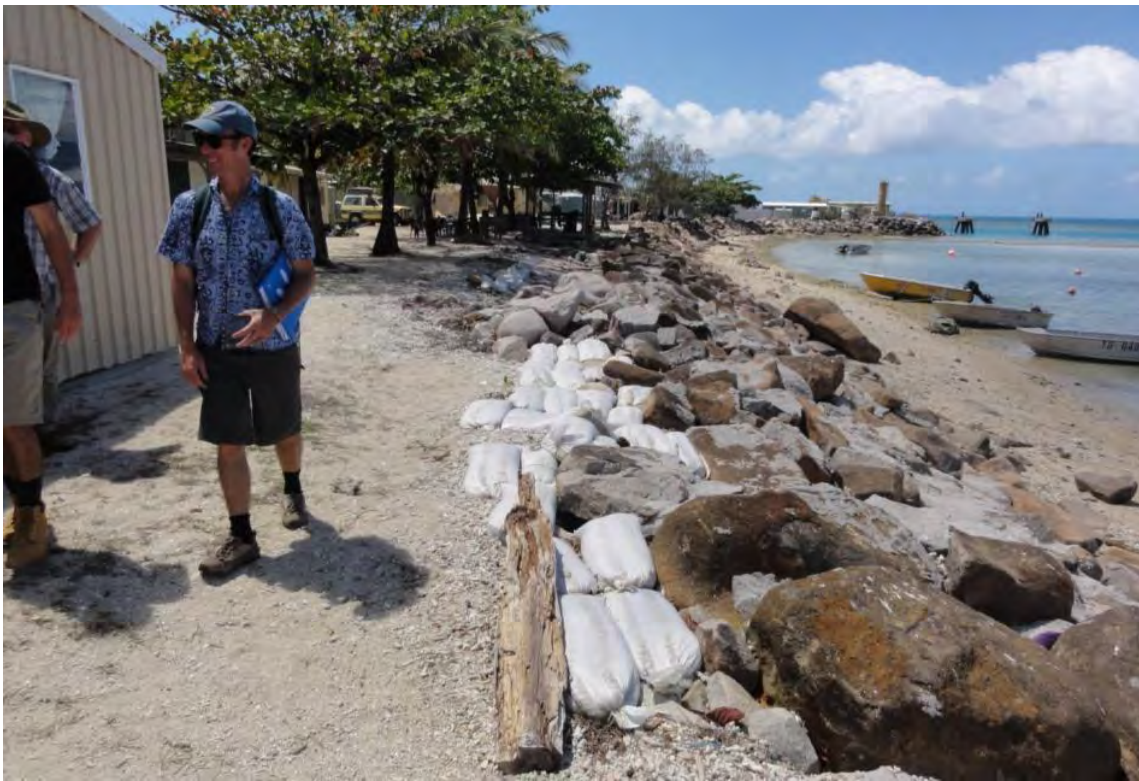
A major issue for the spit is the regular inundation during the king tides in January and February. During these events significant overtopping of the seawall occurs and the area experiences inundation more than other parts of the community. Locally people have attempted to stabilise the areas behind the seawall with block walls and sand bags (refer Figure 46)

Figure 46 Sand bagging to stabilise areas behind seawall

If habitation of the area is to continue, the seawall needs to be reinforced/repared and a wave return wall constructed to exclude the high tide waves that occur. This work would require additional toe armour to be placed along the length of the seawall to stabilise the structure from undermining and the repair of the crest of the structure. A wave return wall, with special toe detailing to protect against scour of material in front of the wall would occupy the first metre or so of land behind the armour and will require the relocation/removal of structures built close to the foreshore (refer Figure 44 and Figure 48) and some mature trees. On the eastern side of the spit the construction of an earth embankment with a crest height approximately 0.5m lower than the wall can exclude inundation from that direction.

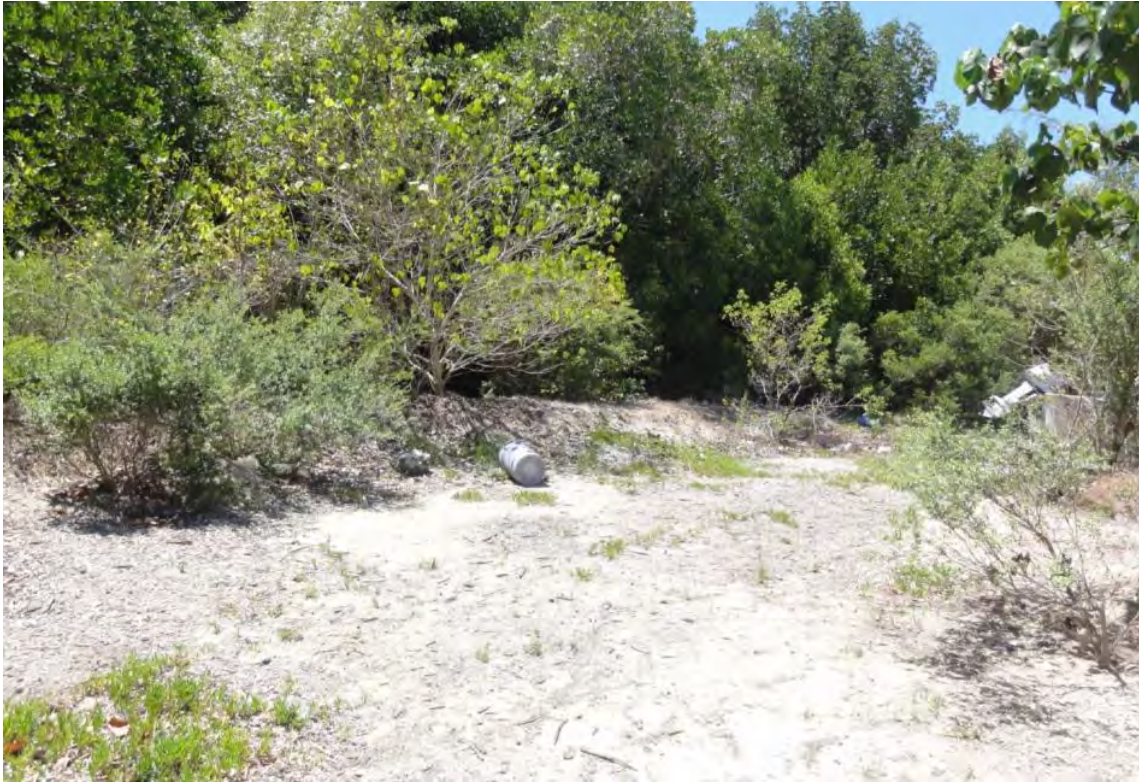
Inundation from the rear of the spit is also an issue with land on the eastern side of the spit lower than the land facing the sea. There are however no waves on the rear side. Some local attempts have been made to keep high water out by the construction of low earth bunds (refer Figure 47), masonry walls and sand bags.

Figure 47 Earth bund to exclude sea water eastern side of the spit

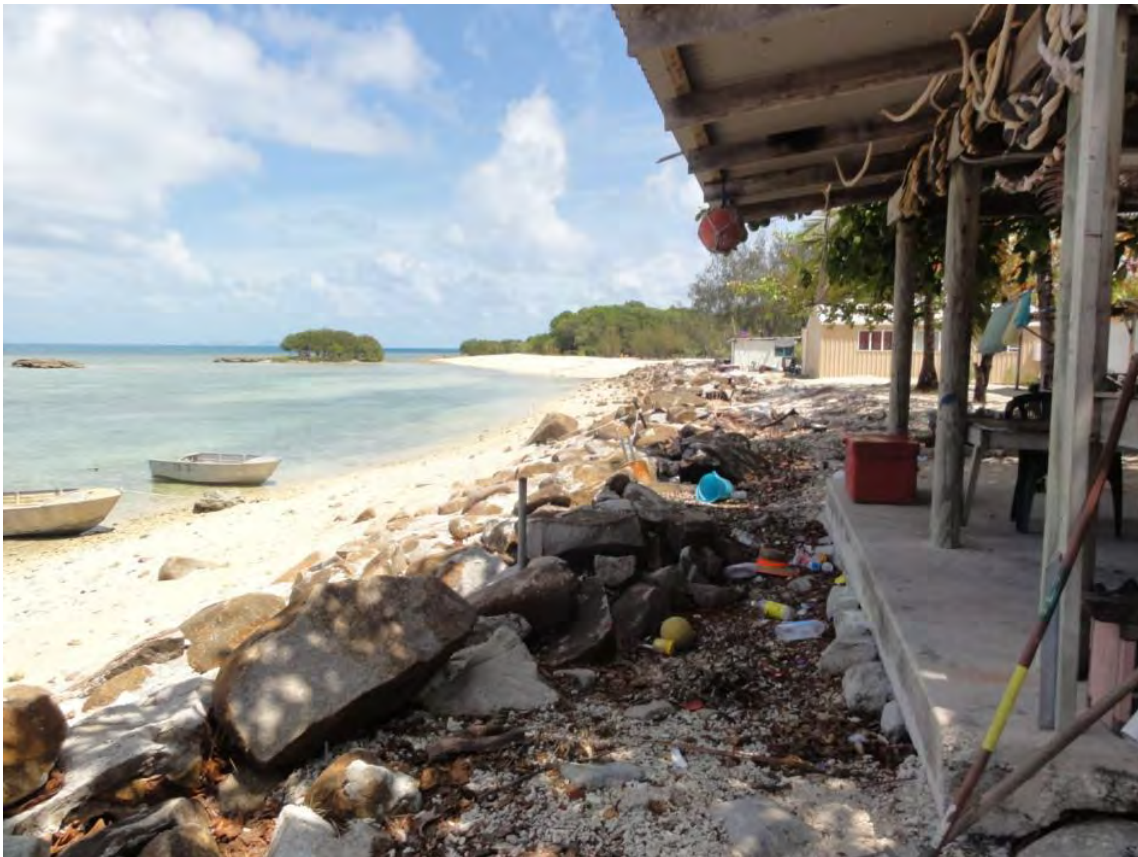
Figure 48 Structure near seawall crest.

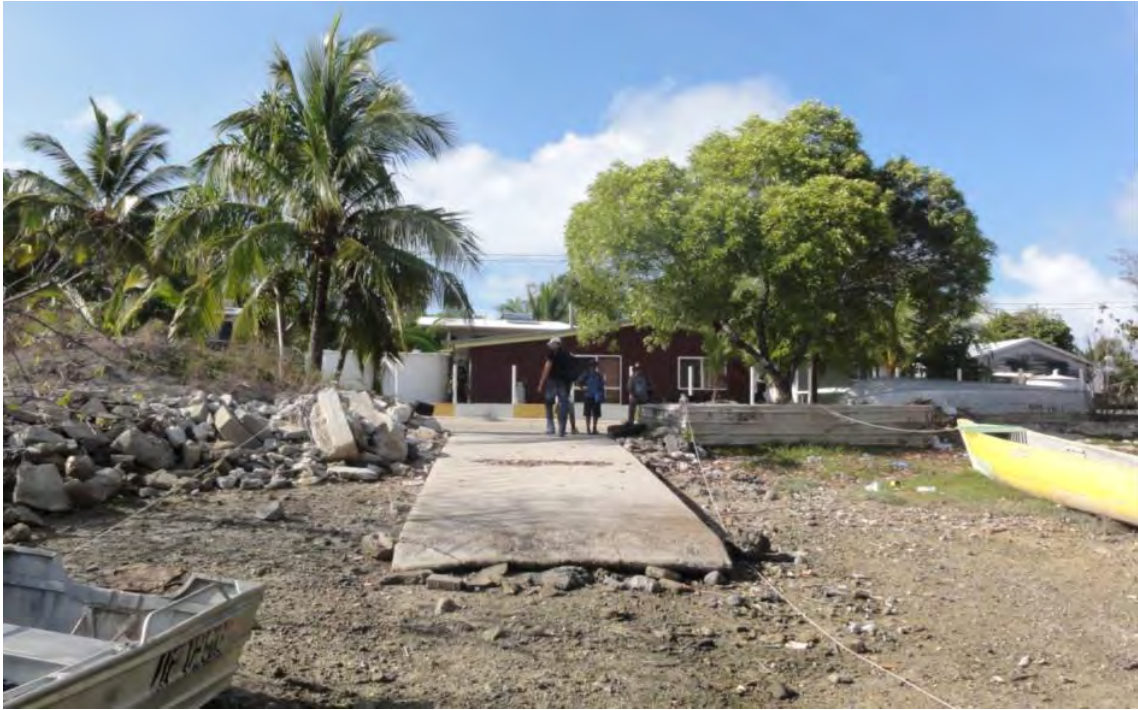
Concern was expressed that the alternate high tide boat ramp located in the mangroves near the airport is an area that is exposing the community to inundation risk by providing an easy flow path into the community (refer Figure 43 and Figure 49). The existing foreshore defences in this area consist of a low wall facing into the mangroves and a more recent and higher wall along property boundaries across the road (refer Figure 50). The boat ramp is providing a gap in lower structure and leads to flooding of the road and the need to sandbag the gaps in the higher wall more frequently than might otherwise be the case. If the boat ramp crest were raised to the same level as the adjacent wave wall structure it would improve the flood immunity of the road and reduce the need to sand bag driveways. This is an issue that council is aware of.

Figure 49 Low Foreshore at alternate boat ramp.

Related to the boat ramp is the vulnerability of the second and more substantial wall (painted yellow and white) because of the gaps left in the wall for vehicular access. These gaps are blocked with sand bags when the risk of flooding is high. A more permanent solution might be attractive to council. This could either be a ramped driveway that rises to a level equivalent with the wall or the provision of light weight gates that can be dropped in place.

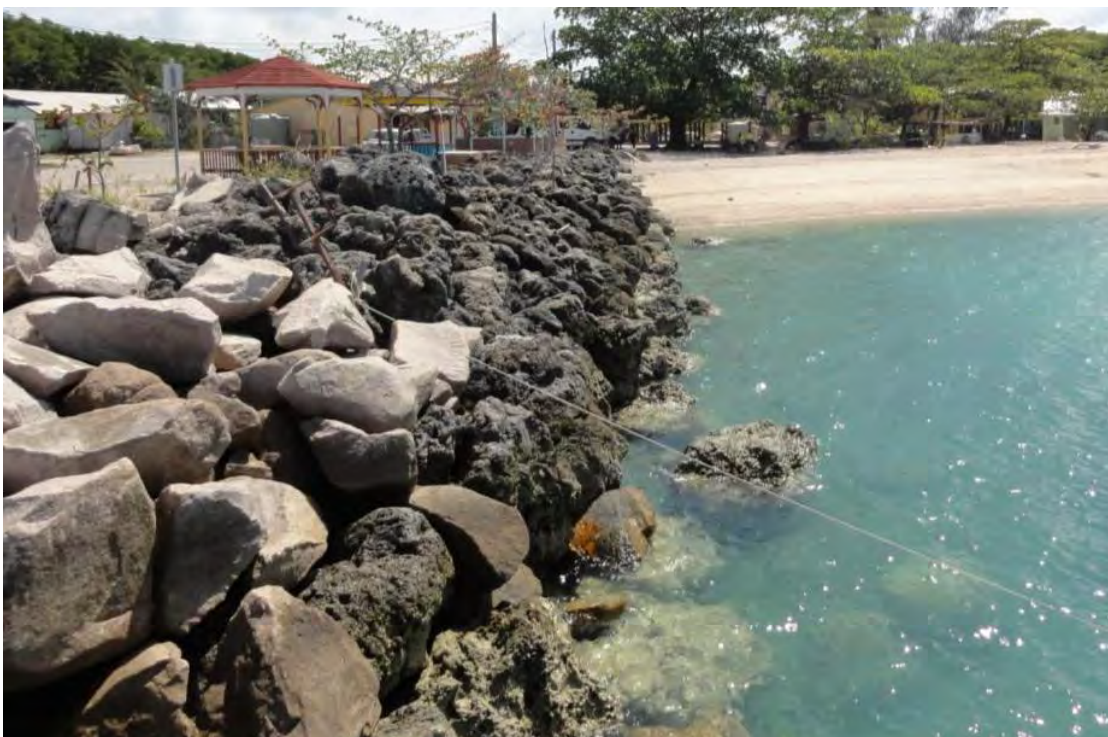
An economically attractive alternative to sourcing rock off the island is the mining of the reef material such as the armour often found in use near the dredged channel, as seen in Figure 54. This option has not been actively examined here on the grounds of environmental and community concern, however the design could be easily altered to suit this material if required.

Figure 54 Rock armour seawall on Iama Island (note the native rock in foreground and the coral rock beyond)
